# The Corporation of the Township of Macdonald, Meredith and Aberdeen Additional

## *Environmental Centre Condition Overview*

November 15, 2024  
Prepared by:

2458.03

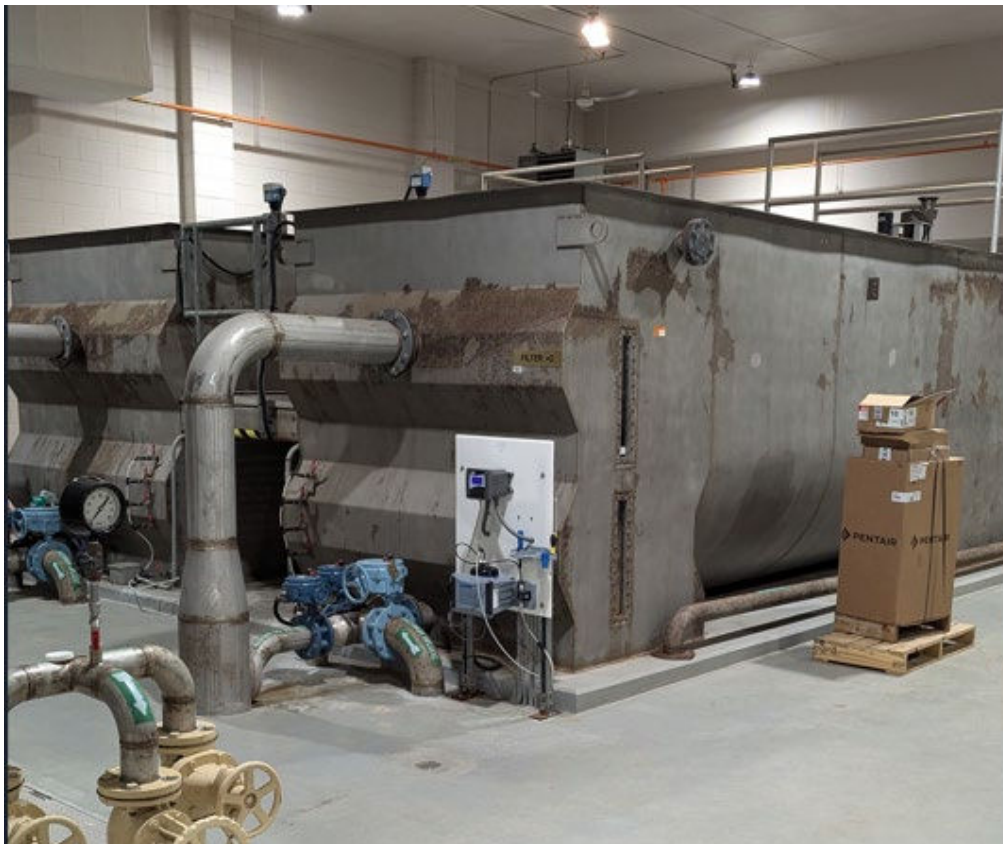
The stainless steel filtration plant tanks (filters and GAC contactors) are displaying signs of corrosion (see photo 7.1). To protect the tanks from further rusting or pitting and potential failure, they should be cleaned, re-passivated and clear coated.

Photograph 7.1: Corrosion on Filter Train Tanks

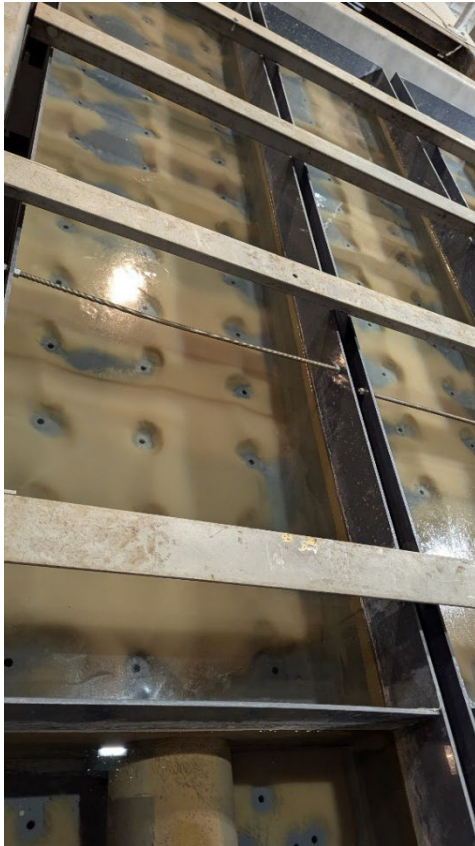
The flocculators are reportedly in good condition; however, the floc recirculator on each treatment plant has failed. Operation of the floc recirculators are critical to the effective operation of the treatment train and they should be reinstated. Though the inclined tube settlers within the clarifiers were not able to be viewed, it is likely that they are in good condition. Build-up of what appeared to be “alum floc” deposited on top of the perforated collection troughs was observed (see photo 7.2), indicating an opportunity for operational improvements. A similar observation, the build-up of floc or “mud balls” on the surface of one of the dual media filters, was also made.

Photograph 7.2: Floc Build-Up on Top of Clarifier Troughs

Alum dose was noted by OCWA to be in the range of 35 to 40mg/L, which is a high dose and could be causing or contributing to the observed build-up on the clarifier collection troughs. The floc recirculators re-direct a portion of already flocculated water from the top of the clarifier back to the flocculation tanks to aid in the formation of new floc. This also aids in the formation of settleable floc for proper removal (by settling) in the clarifier, potentially at a reduced alum dose. The addition of polymer also aids in the formation of floc with improved characteristics (size, mass and bond strength) that support effective settling/clarification. Once the floc recirculators are reestablished, the coagulation and flocculation process should be reviewed to include assessment of alternative coagulants and flocculants and doses. This will also assist OCWA in responding to seasonal or event based changes in raw water turbidity.

5. Replace floc recirculators.	\$30,000	1 year
6. Review alternative coagulants and flocculants.	\$15,000	1 year
7. Replace filter and GAC media.	\$170,000	2-3 years

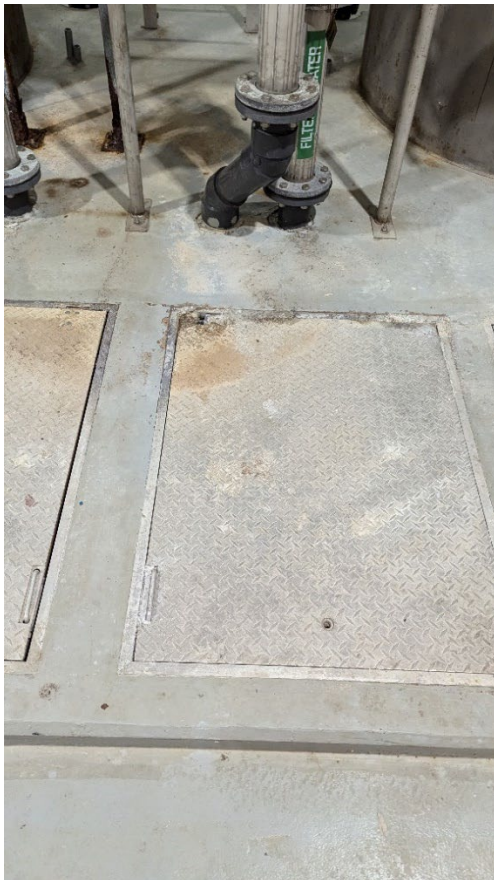
Finished water reservoirs and high lift pump wet wells were last inspected more than 5 years ago. Although no indications of biological growth or build-up of sediments have been reported (e.g. elevated treated water turbidity), the tanks should be inspected using a remote-operated-vehicle at the next opportunity and coordinated with intake and intake pipeline inspections. Isolation valves should continue to be exercised by OCWA. Damage to a GAC well access hatch was observed (see photo 7.3) which should be repaired to ensure the ongoing integrity of filtered water.

Photograph 7.3: Damaged GAC Well Hatch

11. Replace GAC pump well access hatch.	\$25,000	1-2 years
12. Replace two high lift pumps.	\$25,000	1 year
13. Replace SCADA HMI computer.	\$10,000	1 year

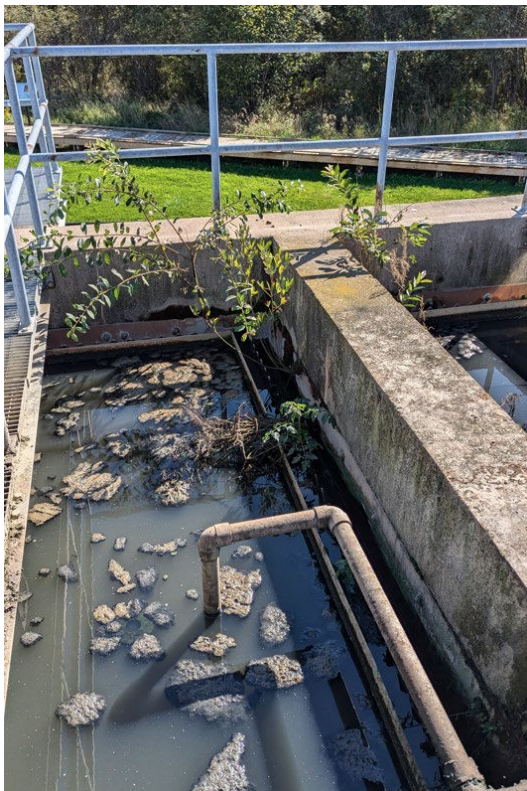
Scum was observed to be accumulating within the primary clarifiers and vegetation was established in the clarifiers (see photo 8.1). The vegetation should be removed, the clarifiers cleaned (pressure washed if required) and the scum air lift systems rehabilitated.

Photograph 8.1: Primary Clarifier Vegetation and Scum Build-Up

<b>Recommendation</b>	<b>Cost Estimate</b>	<b>Priority</b>
1. Develop and implement grit and screenings management procedure (OCWA).	\$0.00	1 year
2. Remove vegetation and clean scum from primary clarifiers.	\$0.00	Ongoing
3. Rehabilitate primary clarifier scum air lift systems.	\$35,000	1-2 years

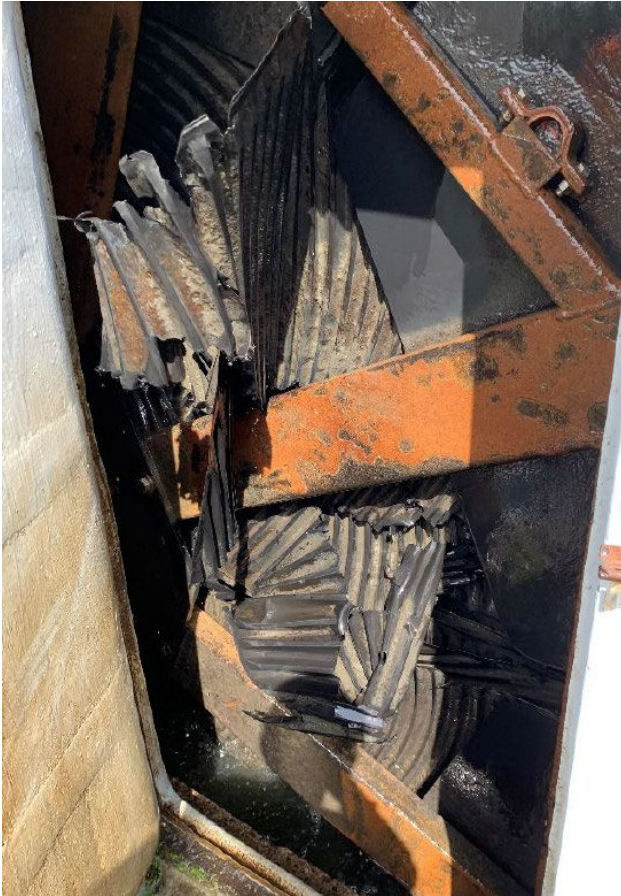
Though not original to the plant, the RBCs have been in service between 9 to 11 years and OCWA has observed that media in RBC #2 has shown signs of failing (see photo 8.2). With proper maintenance, the design life of the pillow block bearings exceeds 20 years. The shaft and media support frames are corrosion resistant. Considering that signs of media failure were observed, and that the RBC's are similar in age (or older) to the original RBC's when they were replaced, the FRP enclosures should be removed to allow detailed inspection of all media packs on each RBC.

Photograph 8.2: RBC #2 Media Failure (photo by OCWA)

<b>Recommendation</b>	<b>Cost Estimate</b>	<b>Priority</b>
4. Remove RBC covers, inspect media packs and shaft, replace media packs as needed.*	\$25,000	1 year
5. Replace secondary clarifier insulated covers.	\$60,000	2-3 years
6. Remove vegetation and clean scum from secondary clarifiers.	\$0.00	Ongoing
7. Assess and rehabilitate secondary clarifier scum air lift systems.	\$40,000	2-3 years
8. Verify functionality of UV system.	\$0.00	Ongoing
9. Replace septic and lime tank mixers (x3).	\$55,000	1-2 years
10. Process pump replacements.	\$15,000	Annually (for 5 yrs)
11. Replace odour control units (x2).	\$85,000	3-5 years
12. Replace composite samplers (x2).	\$50,000	2-3 years

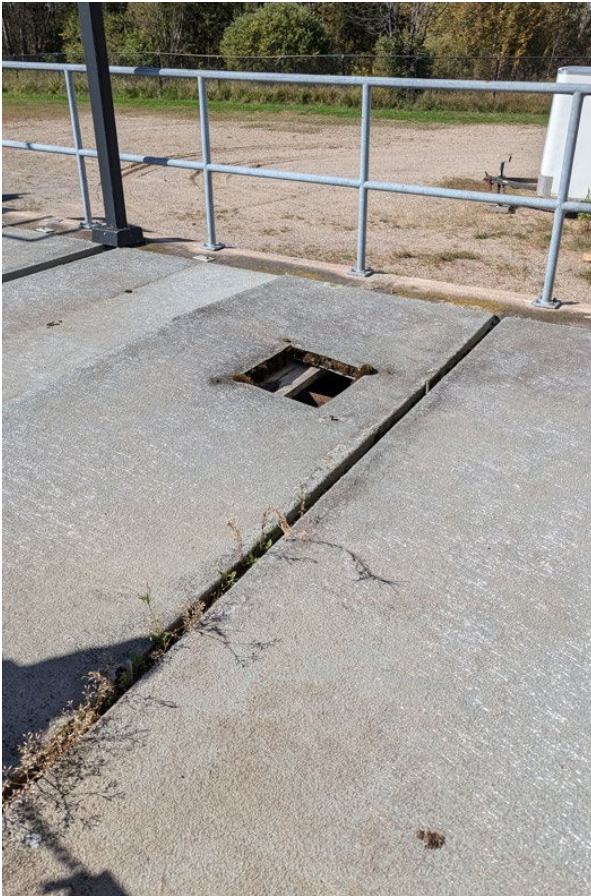
Secondary clarifiers were not able to be viewed fully due to them being covered with insulated FRP panels, which were observed to be in poor condition and should be replaced. Despite this, vegetation was observed to be growing within and/or around the clarifiers (see photo 8.3). The current panels are not easily removed impeding operations staff as clarifier operating conditions are not easily observed and hindering clarifier wash-down and process monitoring activities. Ease of removal should be considered when identifying replacement covers. Once the clarifiers are able to be accessed, vegetation should be removed and the clarifiers cleaned (pressure washed if needed). Accumulated sludge and scum are removed from the secondary clarifiers by an air lift system the condition of which is not known and should be investigated and rehabilitated, if necessary, following replacement of the FRP panels.

Photograph 8.3: Insulated Secondary Clarifier Covers

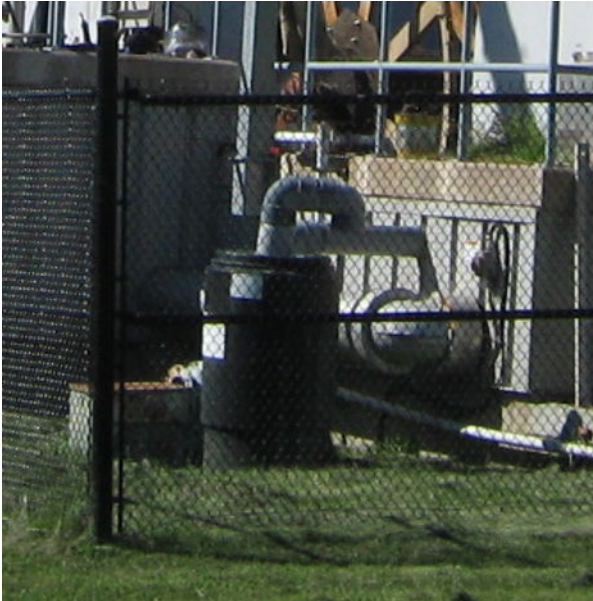
Both odour control units (see photo 8.4) are original to the plant, beyond their service lives and are not functioning. Both units should be replaced.

Photograph 8.4: Odour Control Unit #2

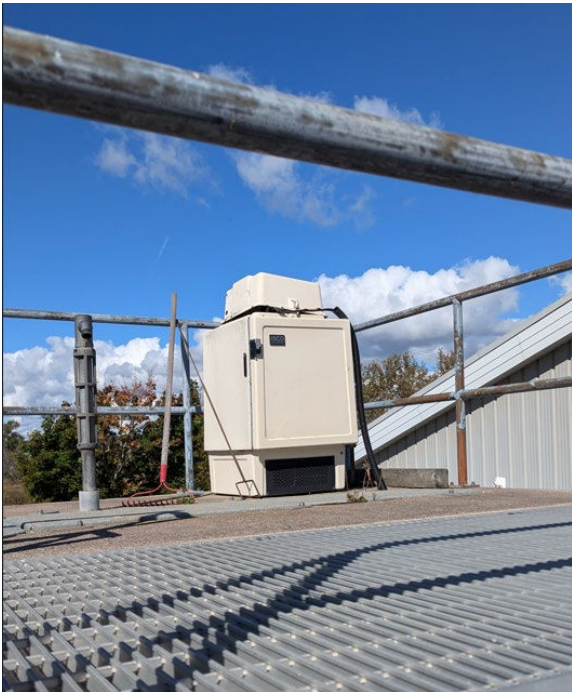
The influent and effluent composite samplers (see photo 8.5) are original to the plant, are beyond their service lives and are in poor condition. Both units should be replaced.

Photograph 8.5: Influent Composite Sampler

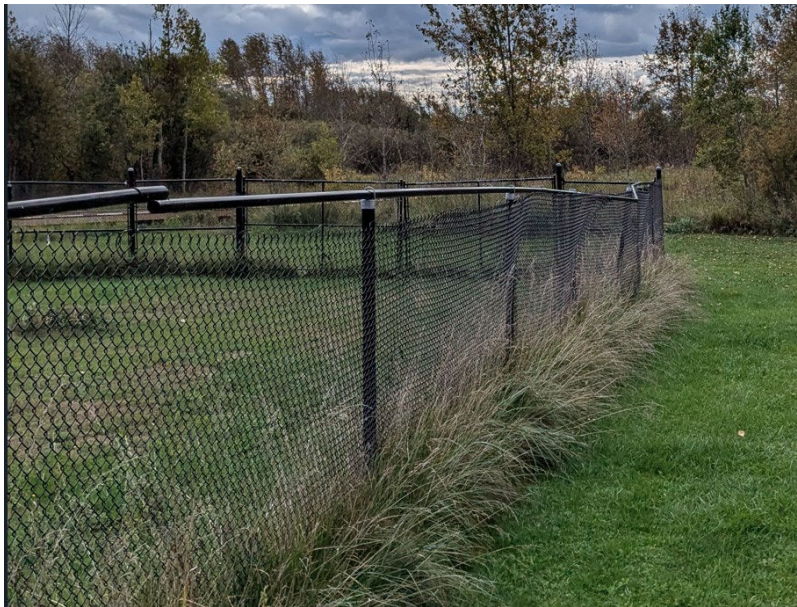
The Environmental Centre grounds appear to be well maintained. Damage to the chain link fence (see Photo 7.1) at the rear of the building was observed and likely due to snow removal activities and/or frost heaving. Efforts should be made to repair the fencing to avoid the damage progressing.

Photograph 7.1: Damage to Chain Link Fence

<b>Recommendation</b>	<b>Cost Estimate</b>	<b>Priority</b>
1. Repair chain link fence.	\$2,500	Maintenance – ASAP
2. Re-set roof screws.	\$0.00	Maintenance - ASAP
3. Monitor for proper operation of building systems.	\$0.00	Ongoing

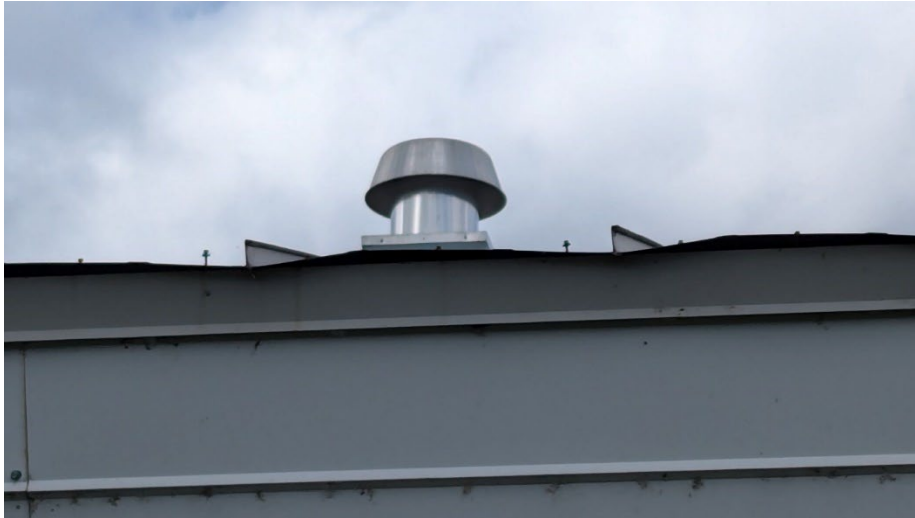
Having undergone roof repairs within the past 5 years, the building envelope is in good condition. It was noted during the site visit that several roof fasteners required re-setting along the east edge of the roof (see photo 7.2). These should be re-set as soon as possible to avoid potential damage to the roof.

Photograph 7.2: Screws Along the East Roof Edge Requiring Re-Setting
