Township of Macdonald, Meredith & Aberdeen Additional

Biennial Bridge and Culvert Inspections 2024

October 2024

KEC Project 2436

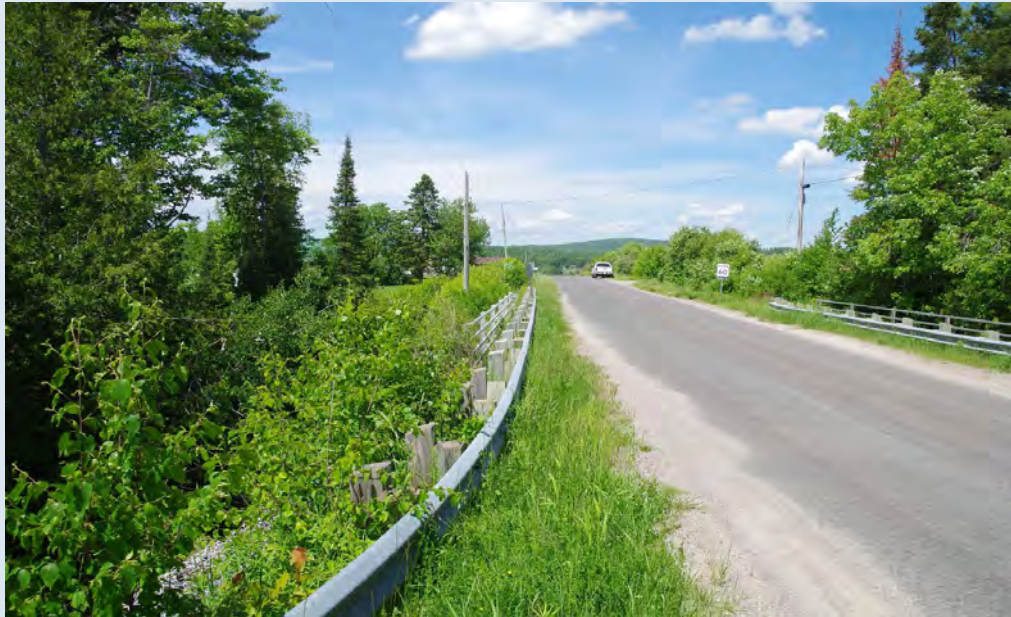
Photo No.: 1

Typical road surface and guide rail condition

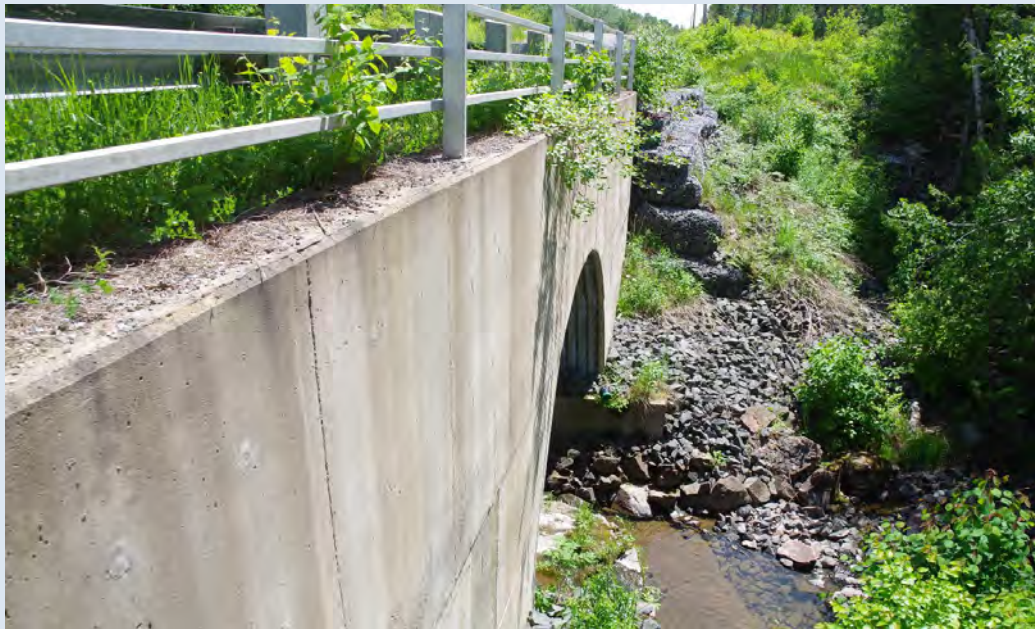
Photo No.: 2

Typical headwall and embankment condition

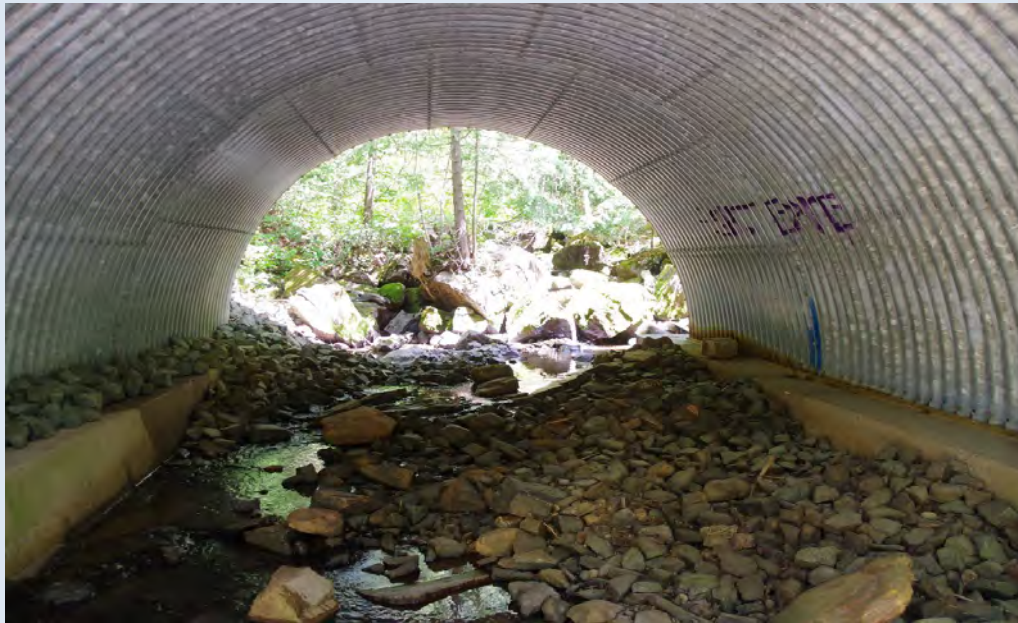
Photo No.: 3

View through culvert.

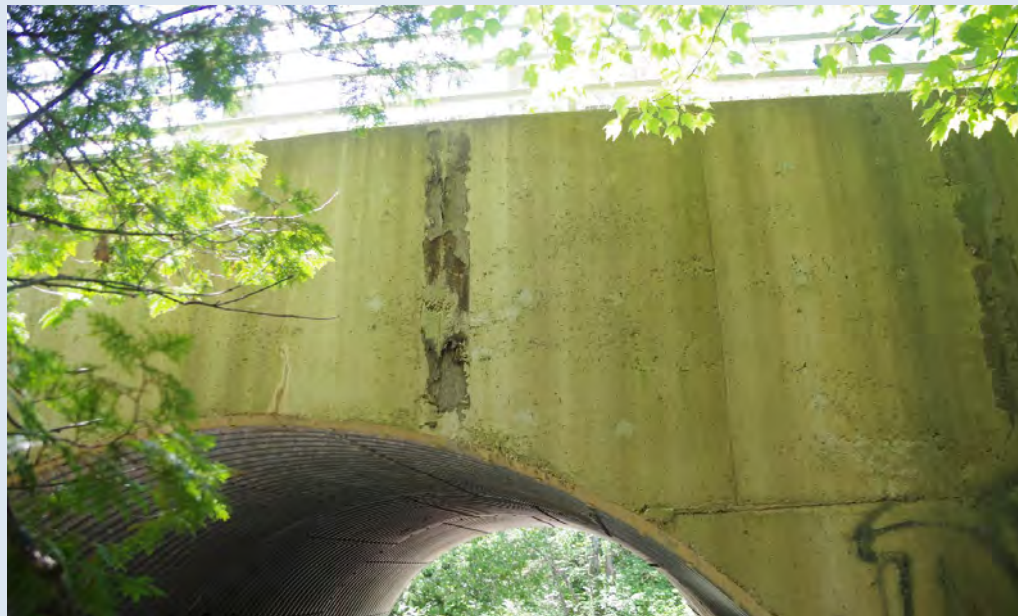
Photo No.: 4

Upstream headwall.

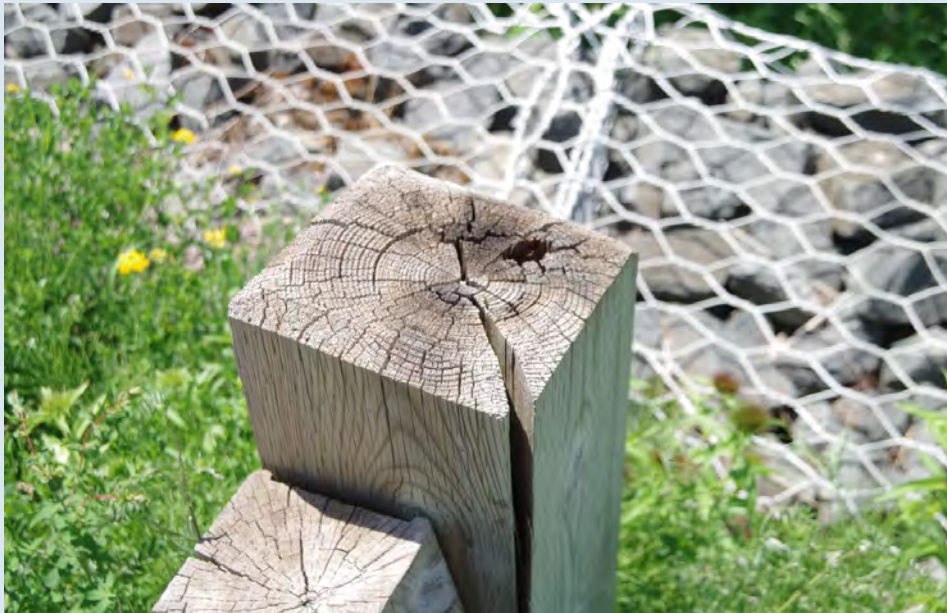
Photo No.: 5

Typical condition of guide rail posts.

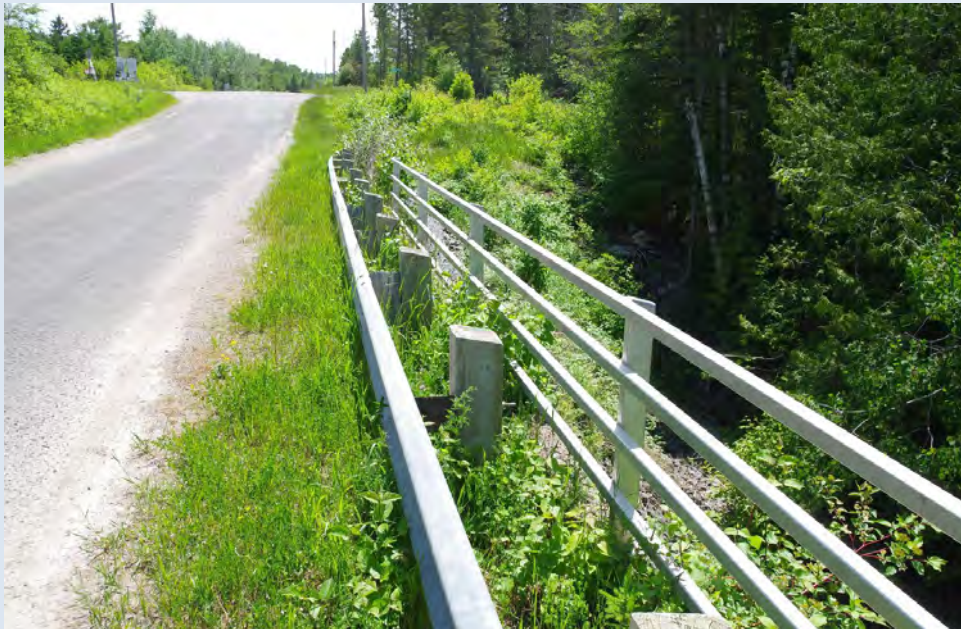
Photo No.: 6

Typical roadside conditions over culvert.

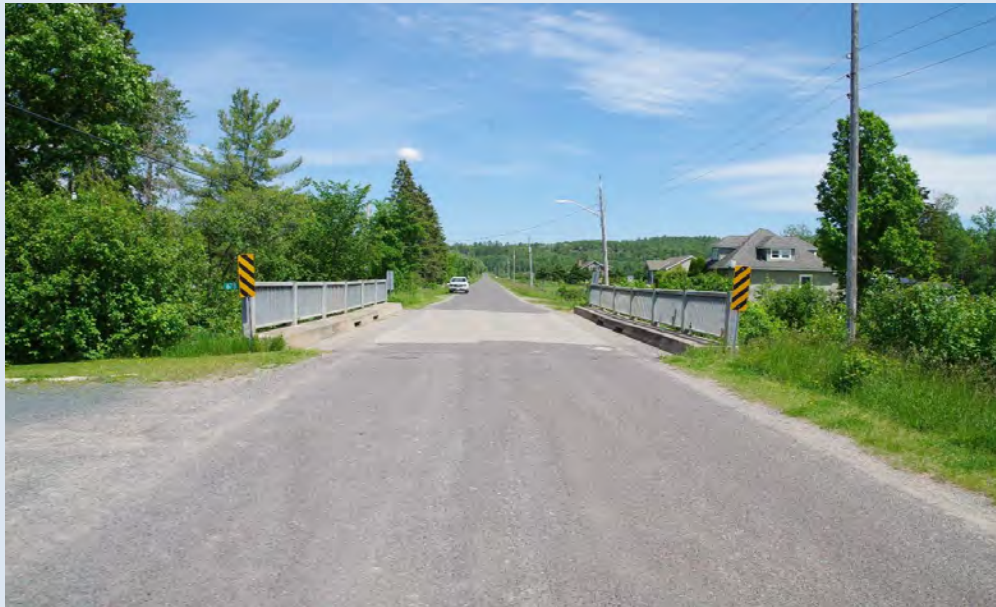
Photo No.: 1

West approach

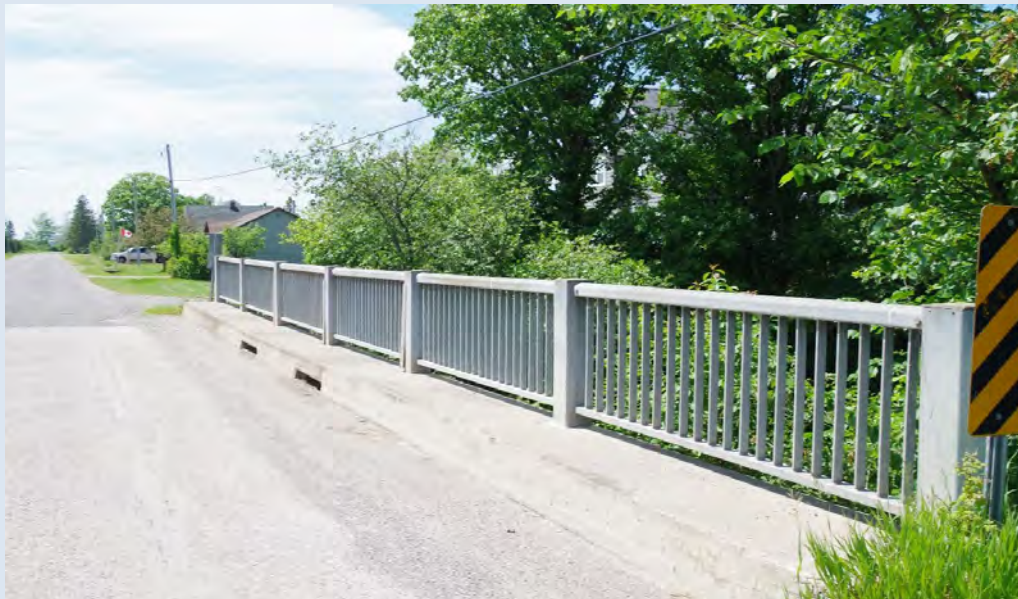
Photo No.: 2

Typical deck, railing and drainage system condition

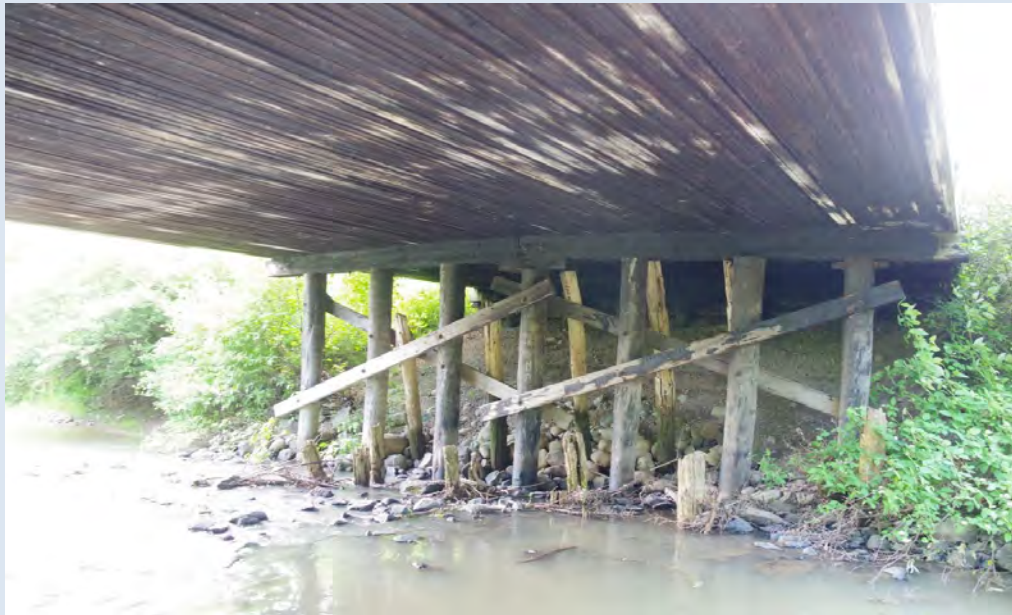
Photo No.: 3

Typical soffit and pier condition

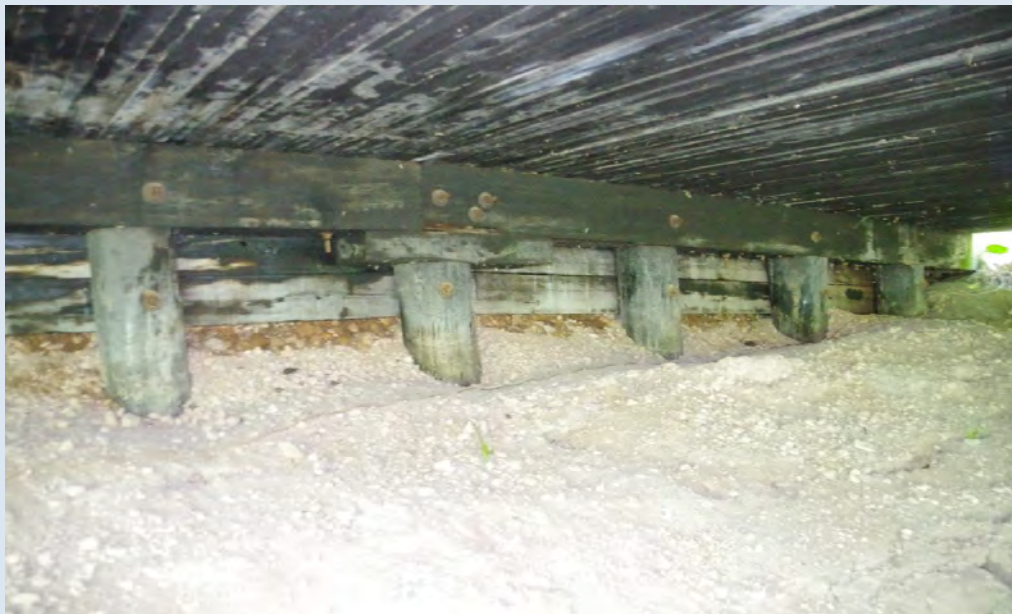
Photo No.: 4

Typical abutment and bearing condition

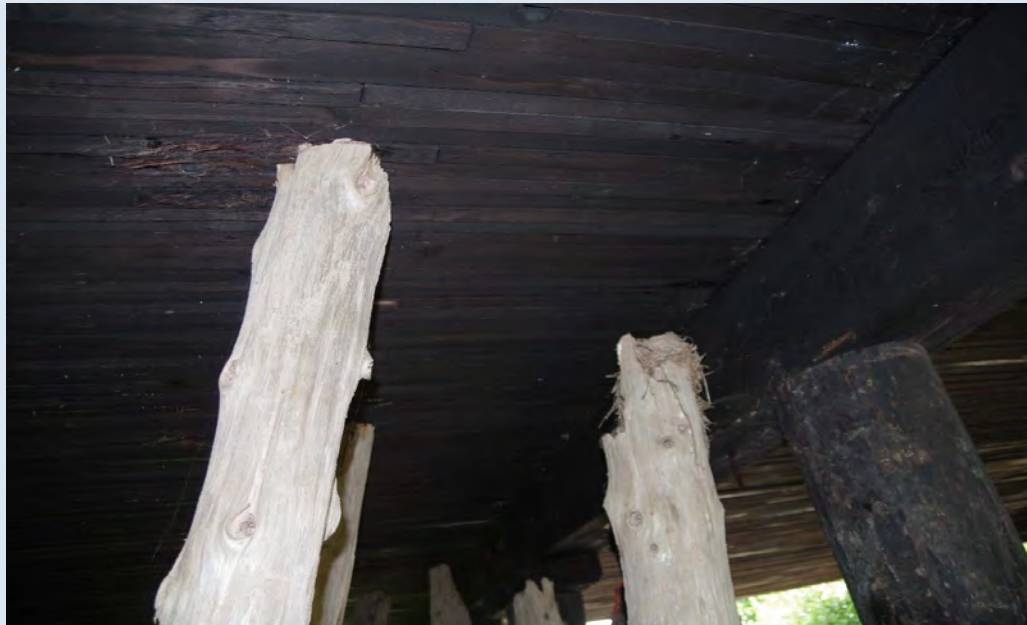
Photo No.: 5

Timber piles from previous bridge are jacking and impacting soffit.

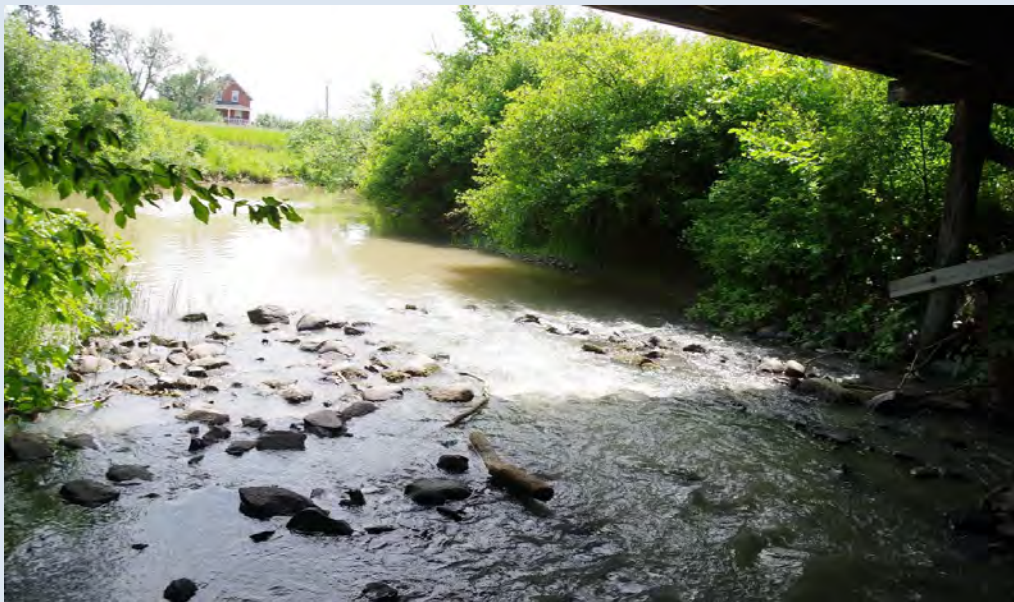
Photo No.: 6

View looking downstream from under bridge.

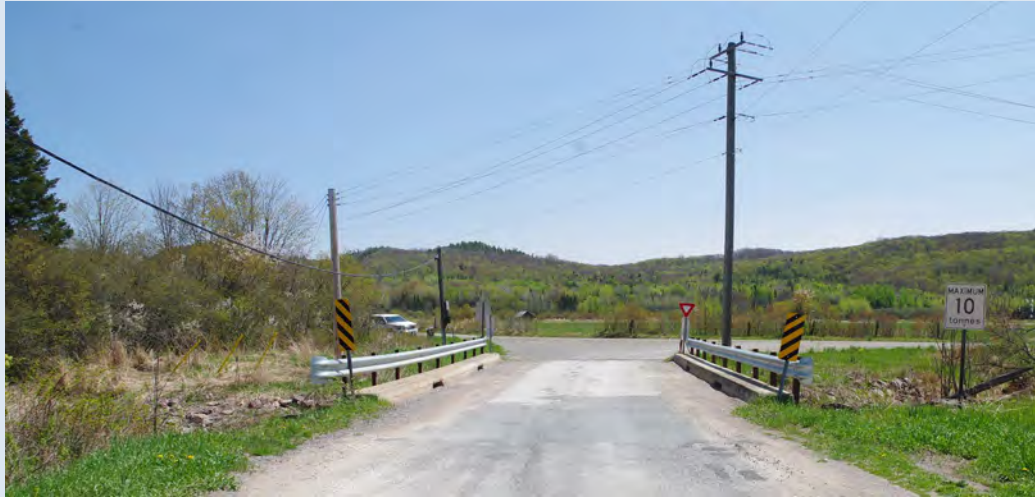
Photo No.: 1

West approach.

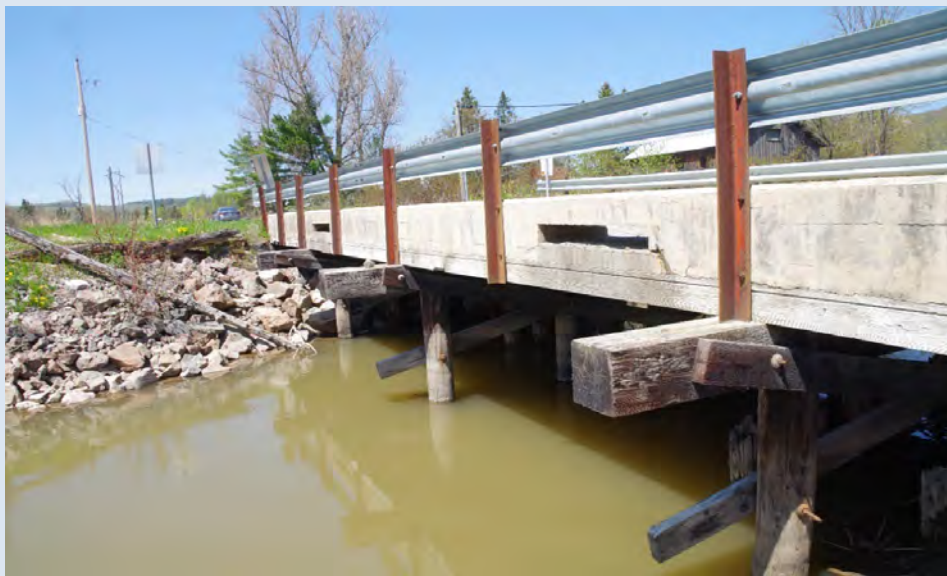
Photo No.: 2

South (downstream) elevation.

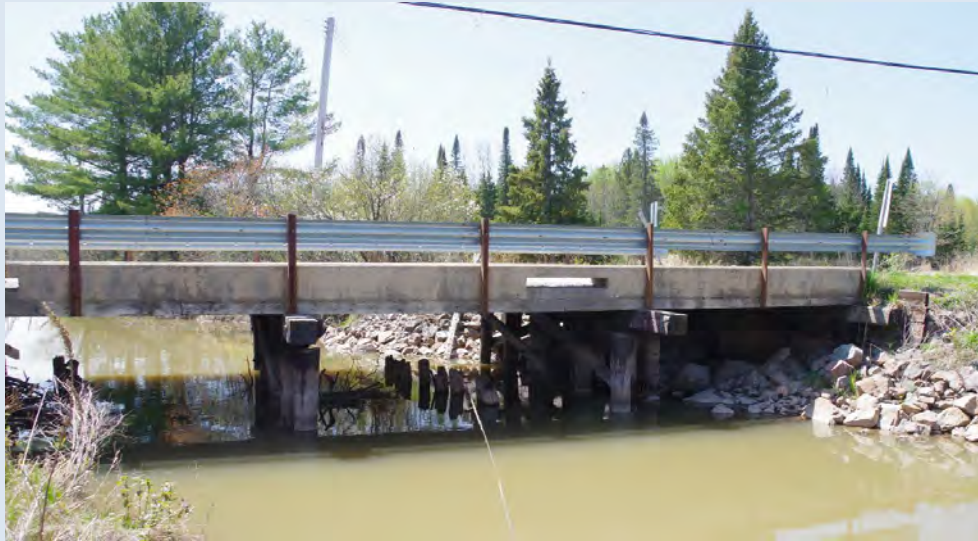
Photo No.: 3

North (upstream) elevation.

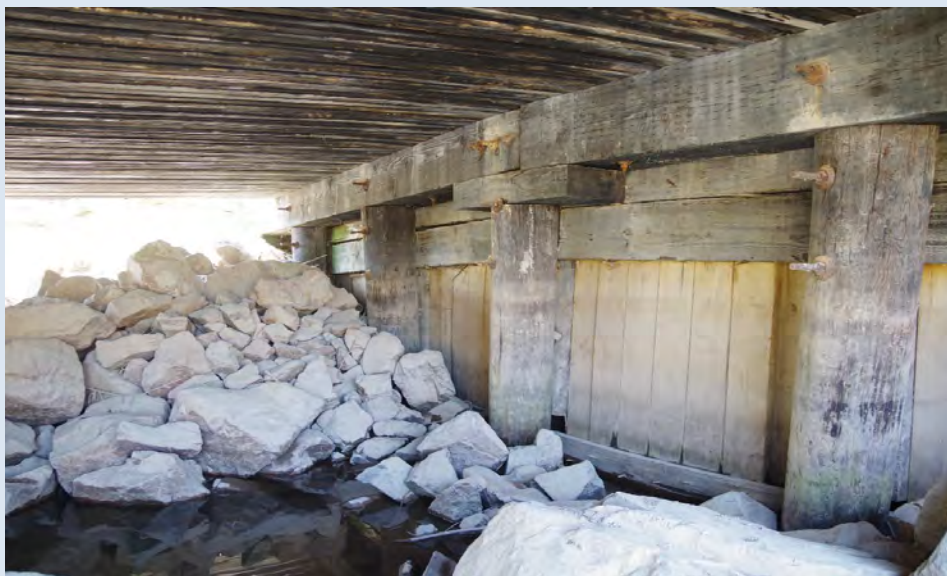
Photo No.: 4

Typical abutment and erosion protection.

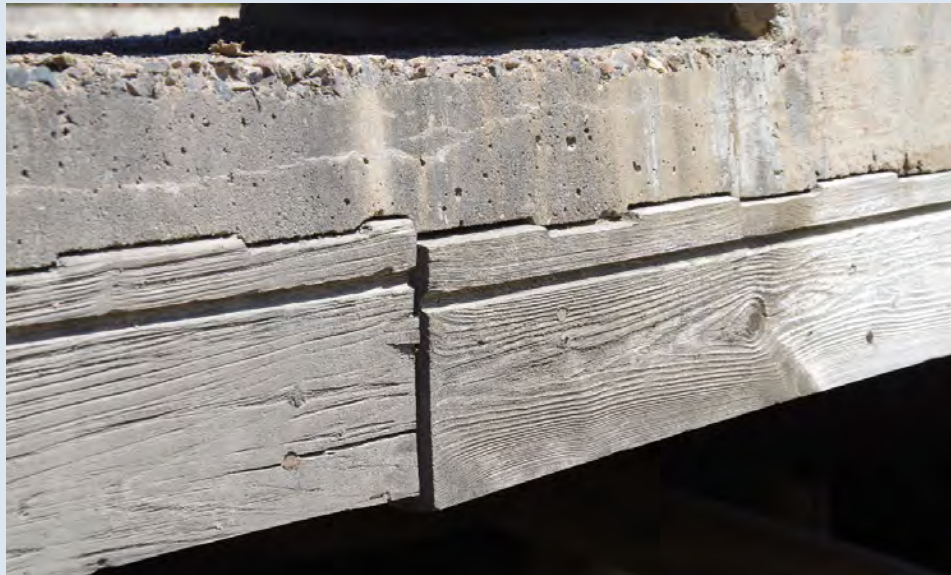
Photo No.: 5

Separation of laminated timber deck from concrete overlay.

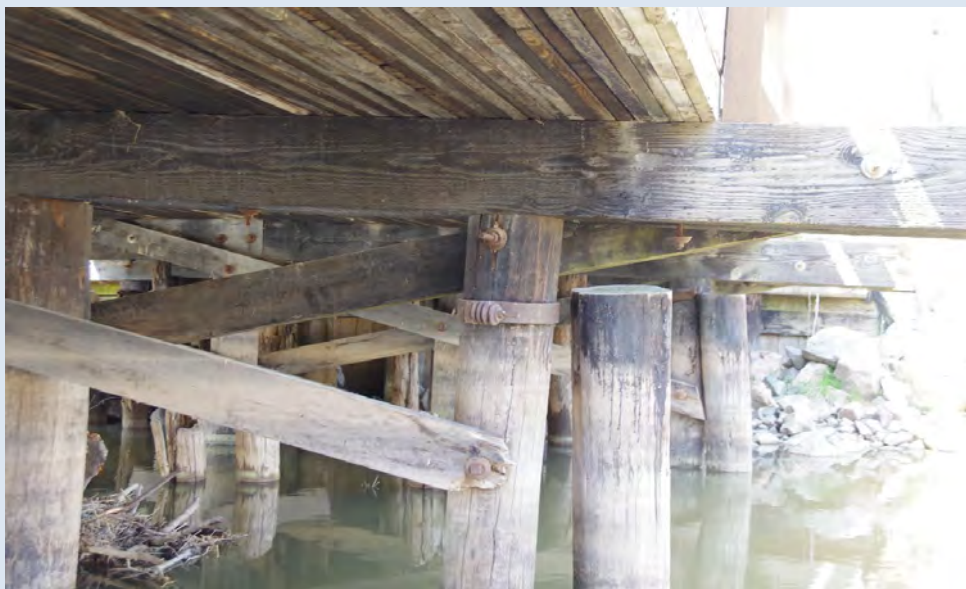
Photo No.: 6

Typical condition of pile bents. Note broken bracing member.

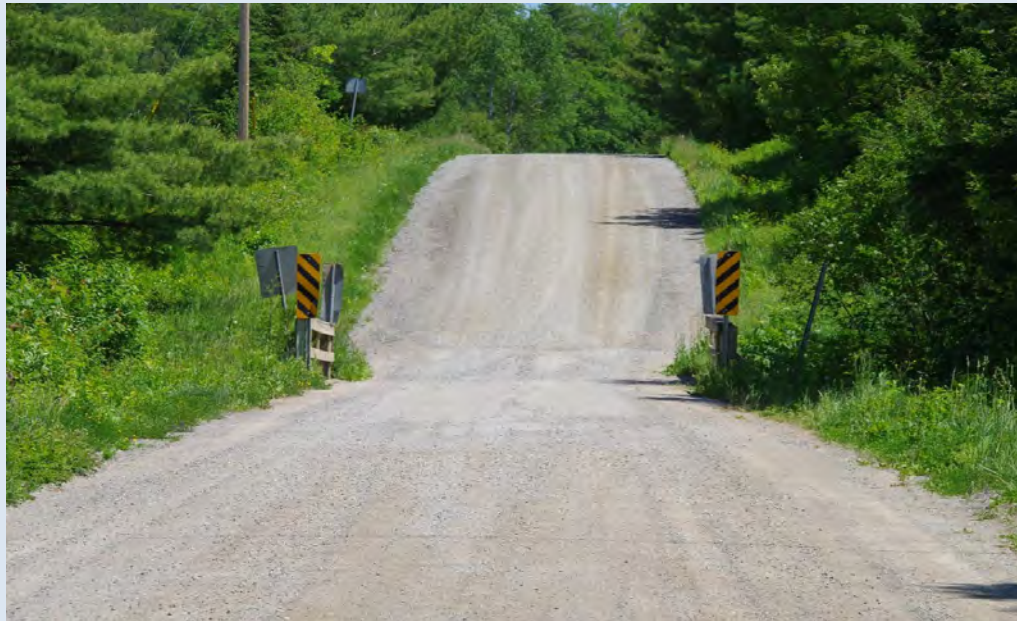
Photo No.: 1

West approach

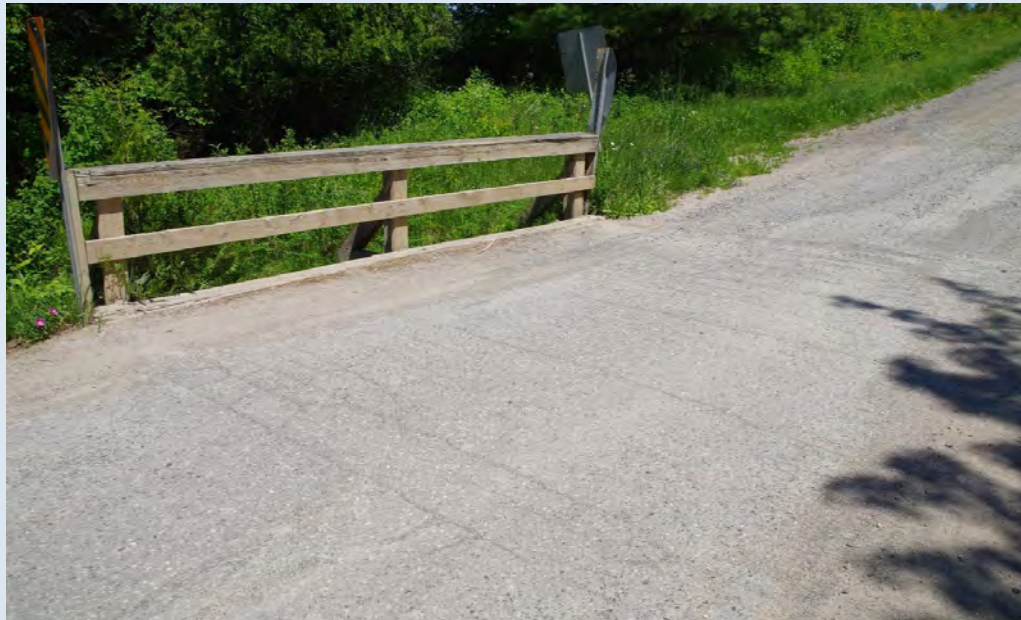
Photo No.: 2

Typical deck and railing condition

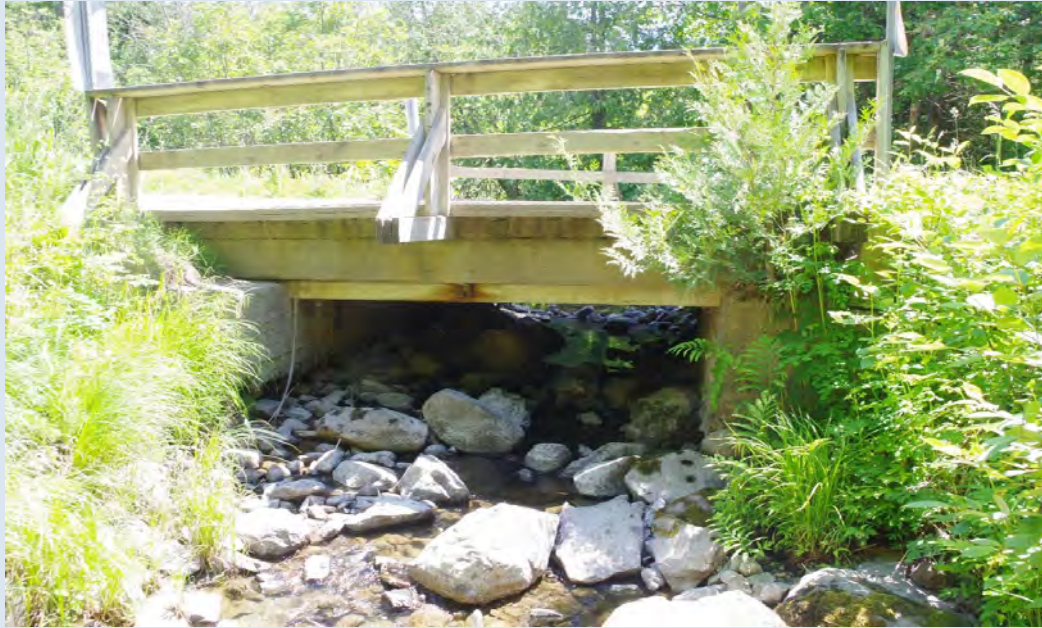
Photo No.: 3

North façade.

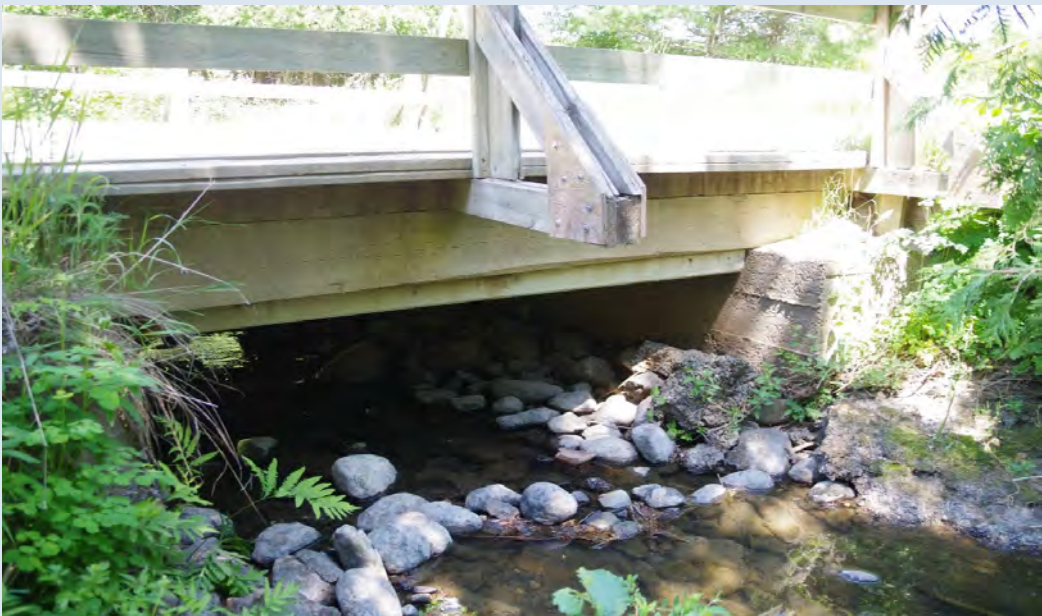
Photo No.: 4

South façade

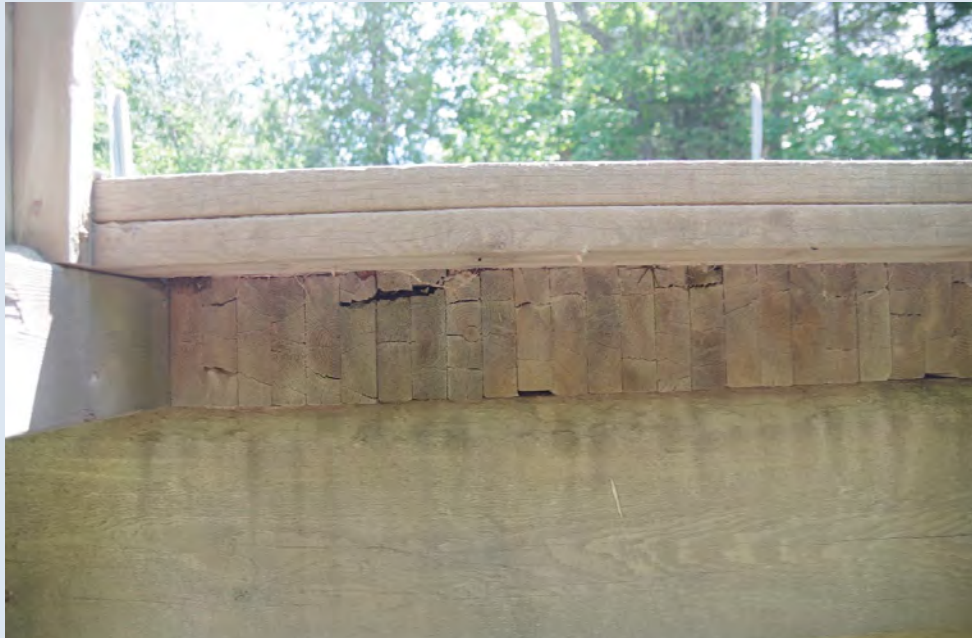
Photo No.: 5

Typical condition of laminated timber deck.

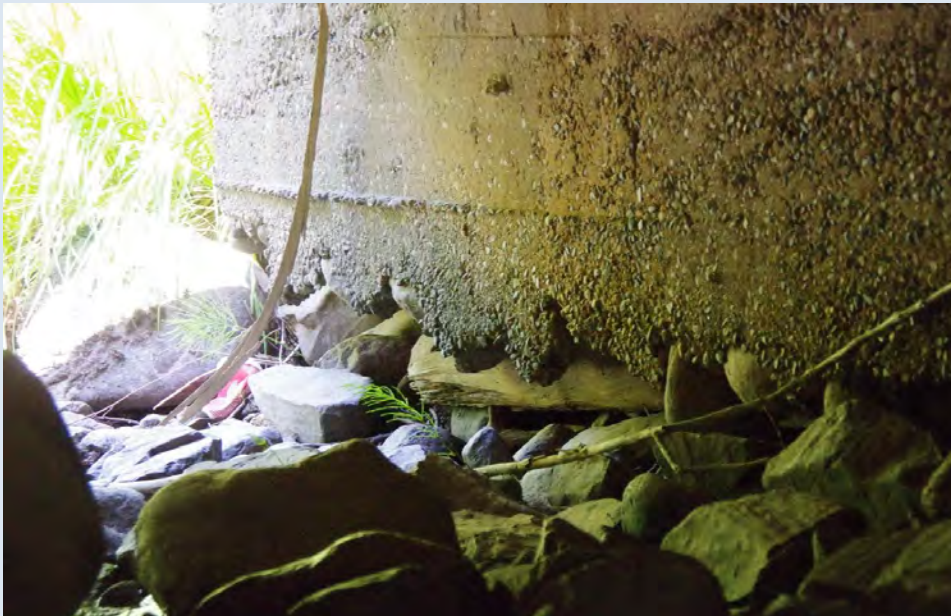
Photo No.: 6

Typical condition of abutment. Note undermining of abutment.

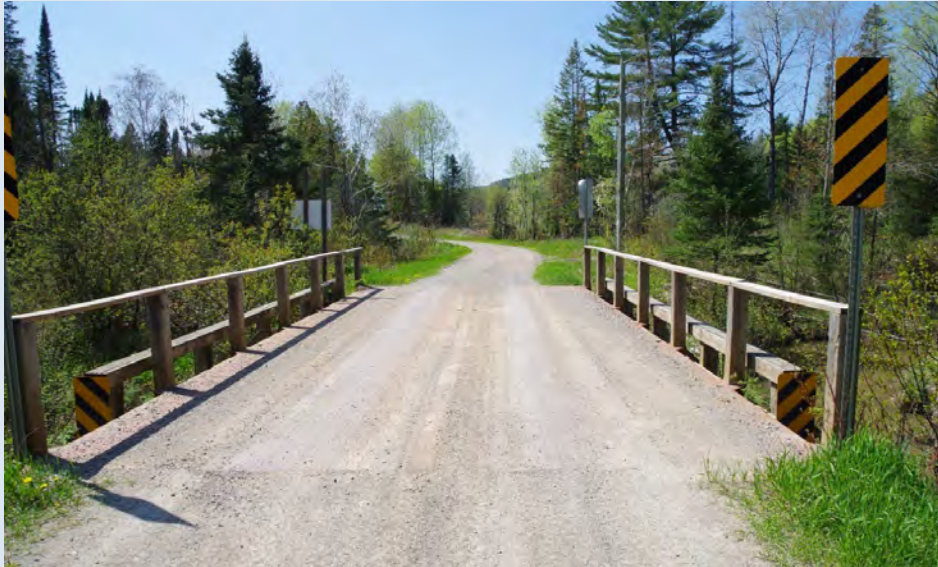
Photo No.: 1

East approach.

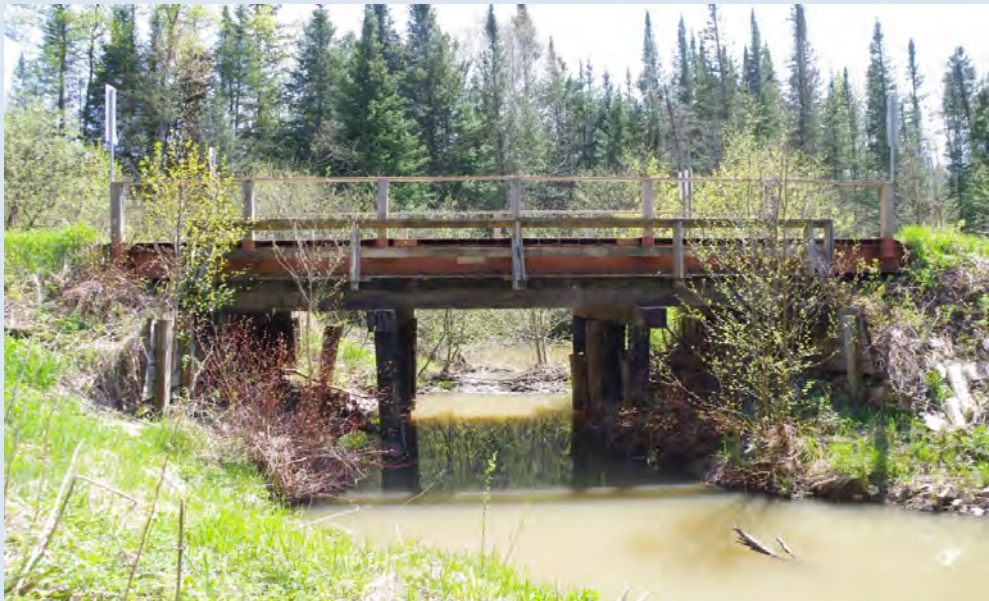
Photo No.: 2

North elevation.

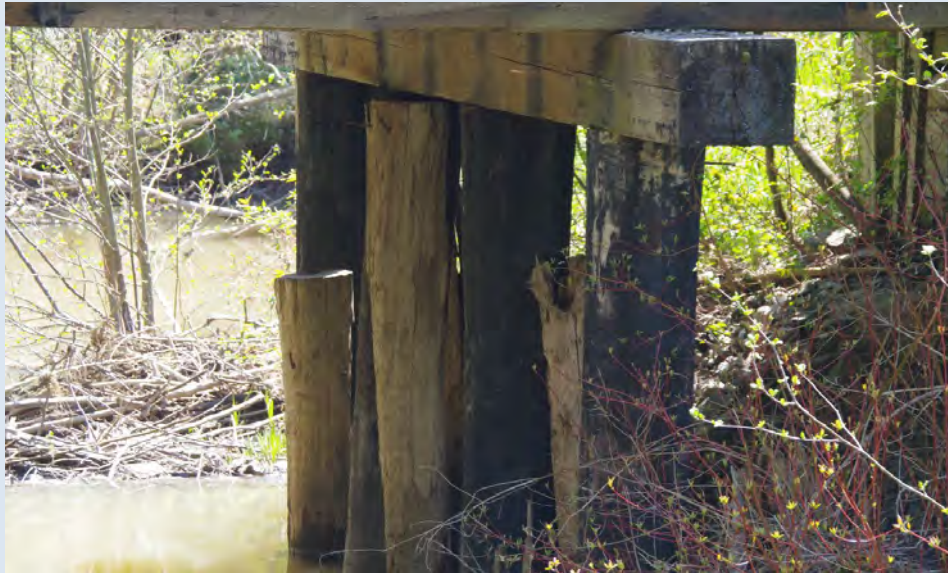
Photo No.: 3

Looking south, west bridge support. Note abandoned piles from previous structure.

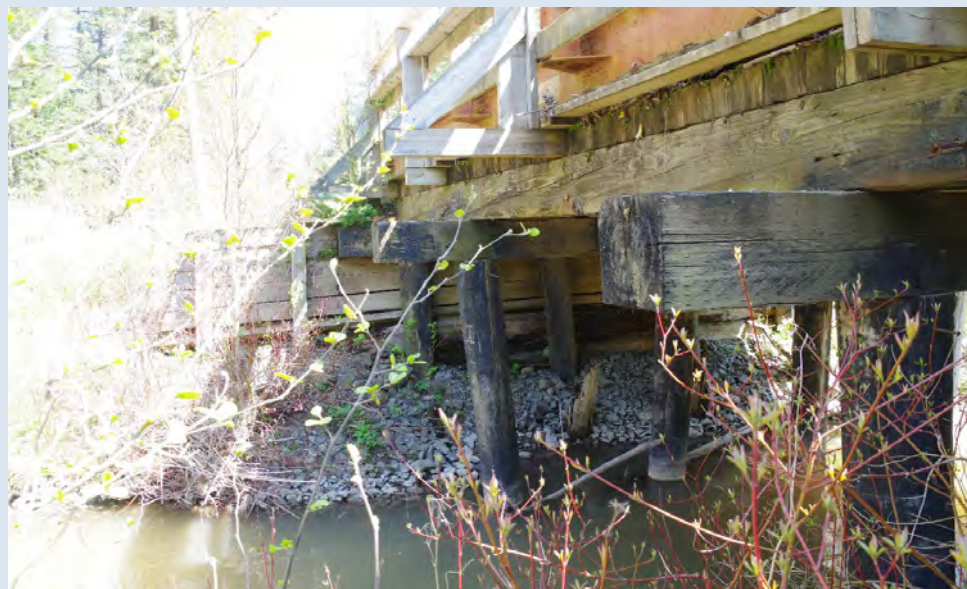
Photo No.: 4

Typical arrangement of pre-fabricated steel bridge on existing timber structure.

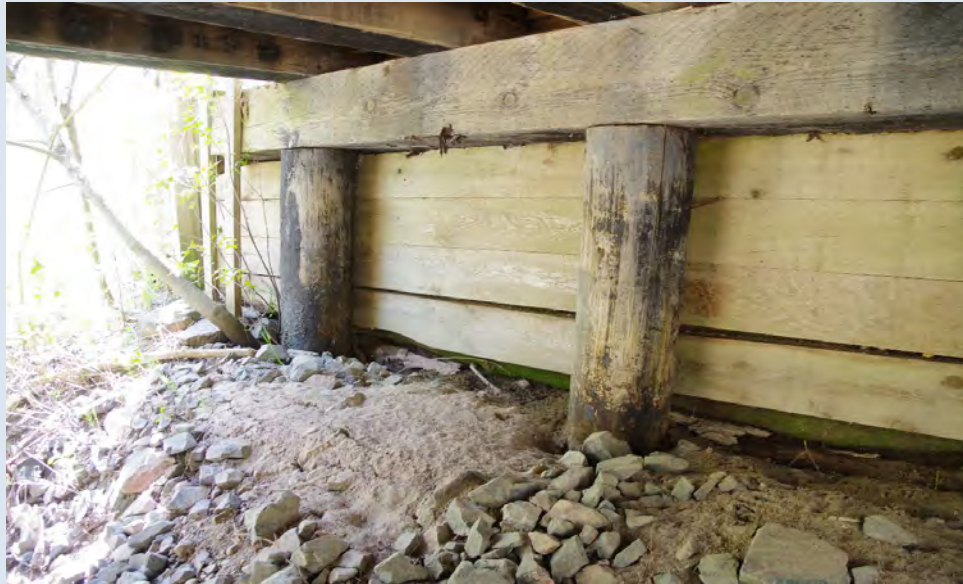
Photo No.: 5

East abutment.

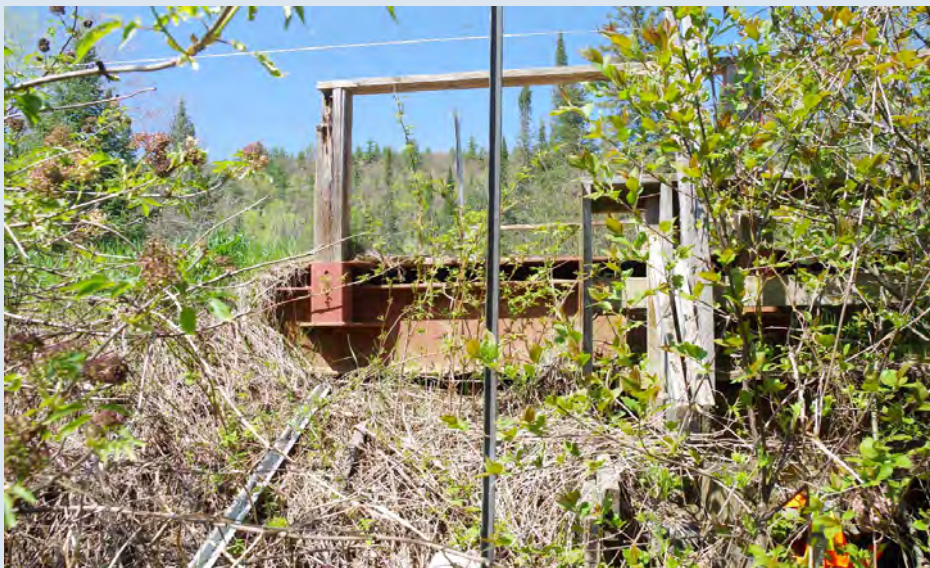
Photo No.: 6

Looking north, west bridge approach, damaged post and hazard sign.

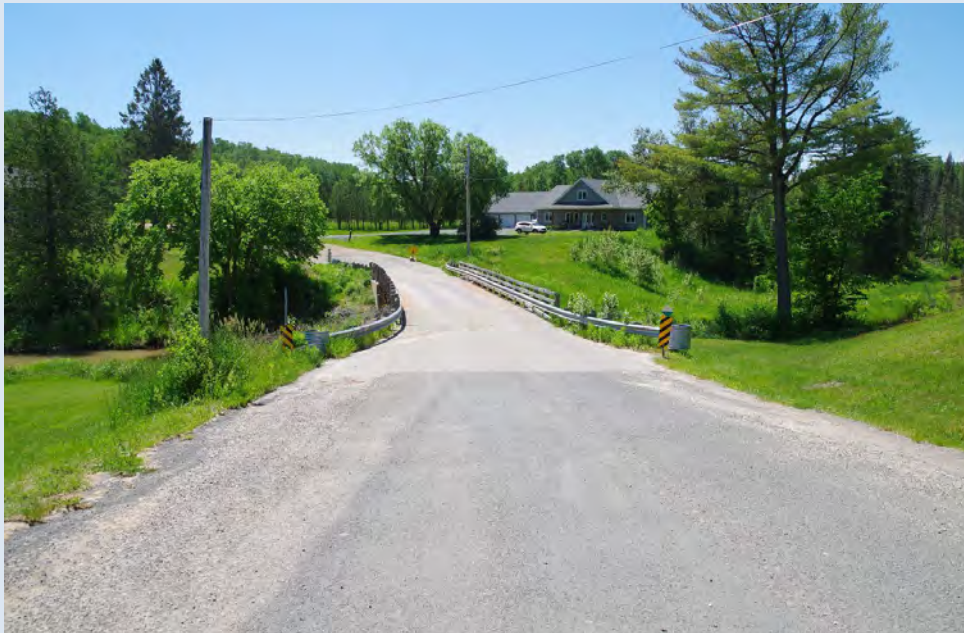
Photo No.: 1

North Approach

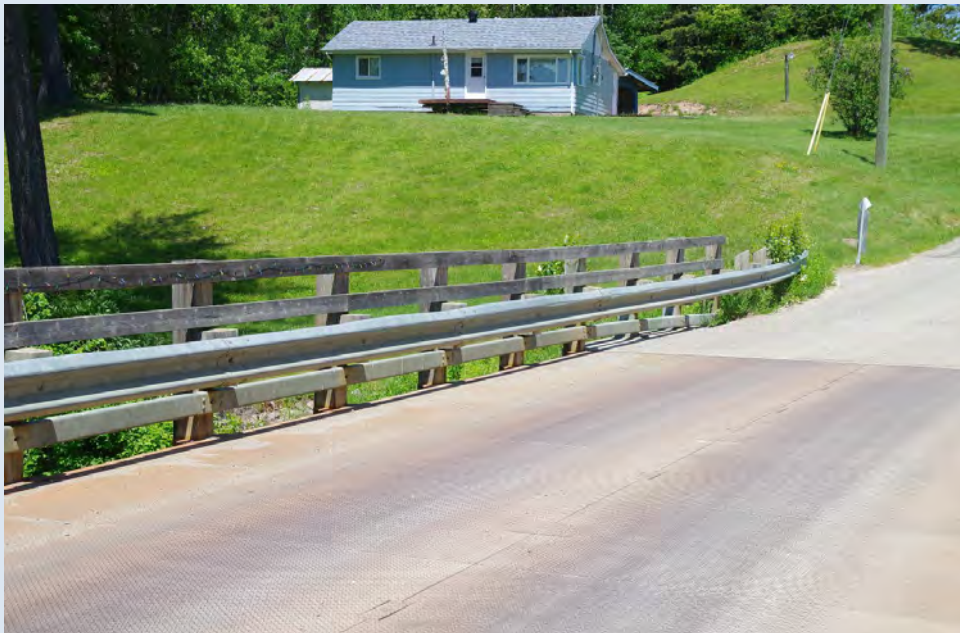
Photo No.: 2

Typical arrangement of hand rail and guide rail. Also note slight polishing of steel deck in wheel tracks.

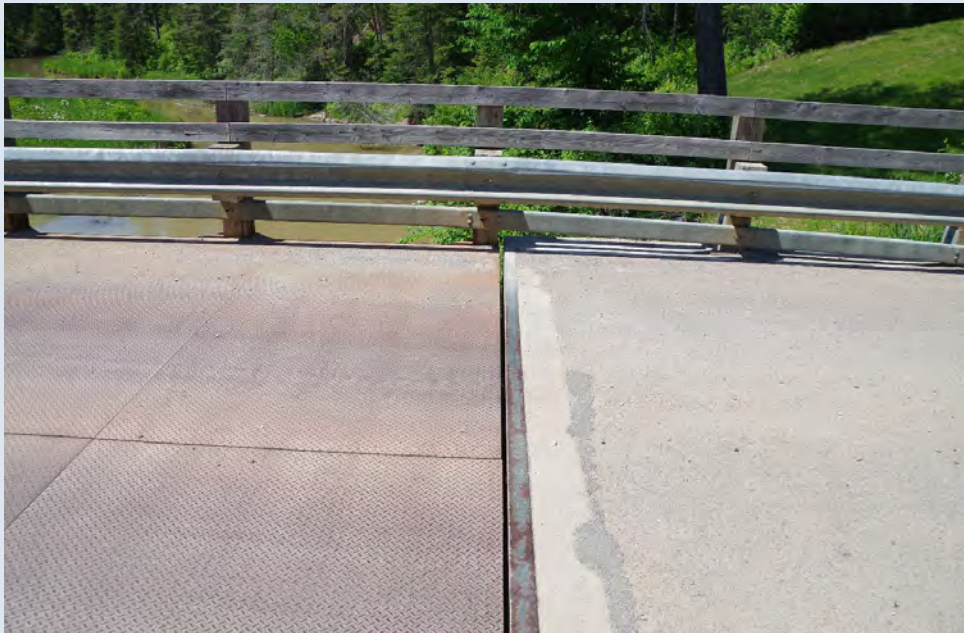
Photo No.: 3

Typical condition of bridge end joints.

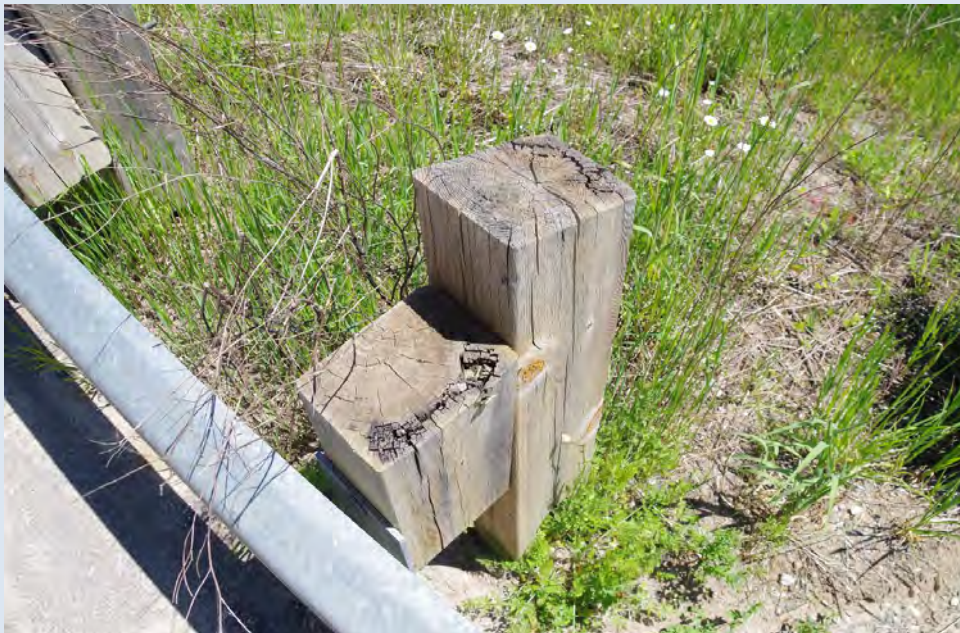
Photo No.: 4

Typical condition of guide rail posts.

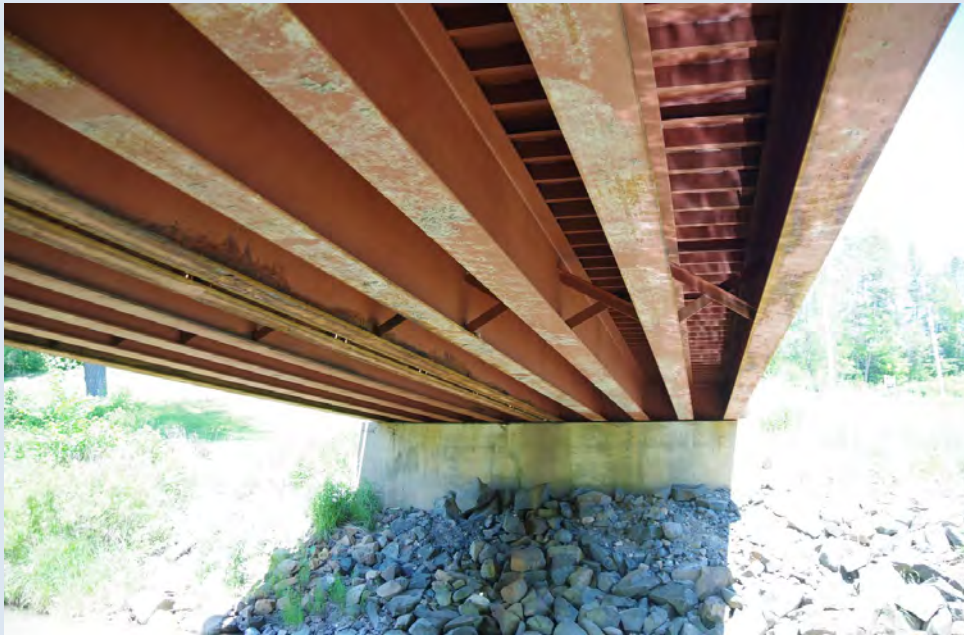
Photo No.: 5

Underside of bridge. Note corrosion of girders at centre of bridge (at centre joint of modular bridge deck)

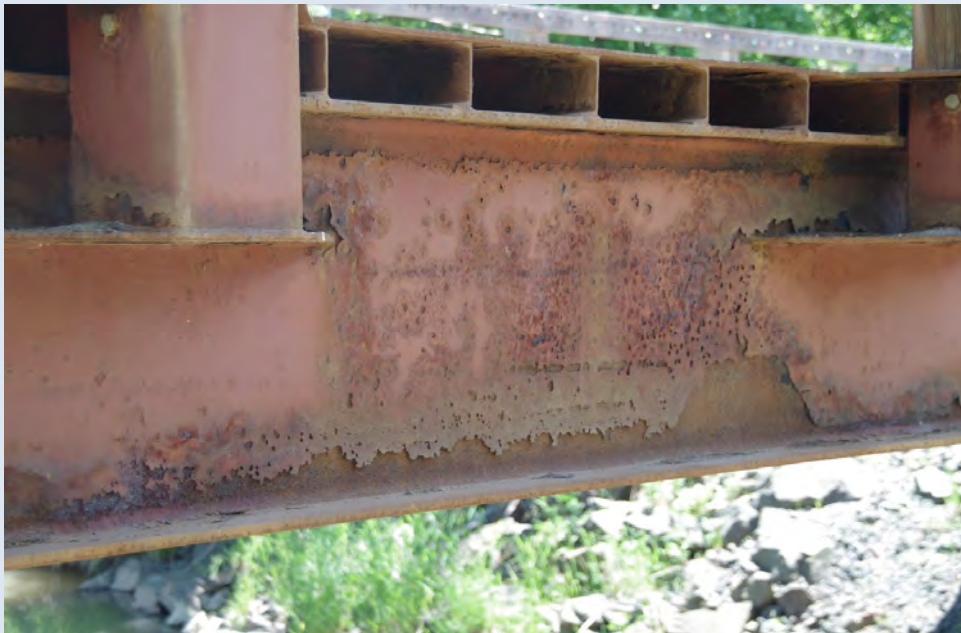
Photo No.: 6

Typical condition of paint coating at exterior girders.

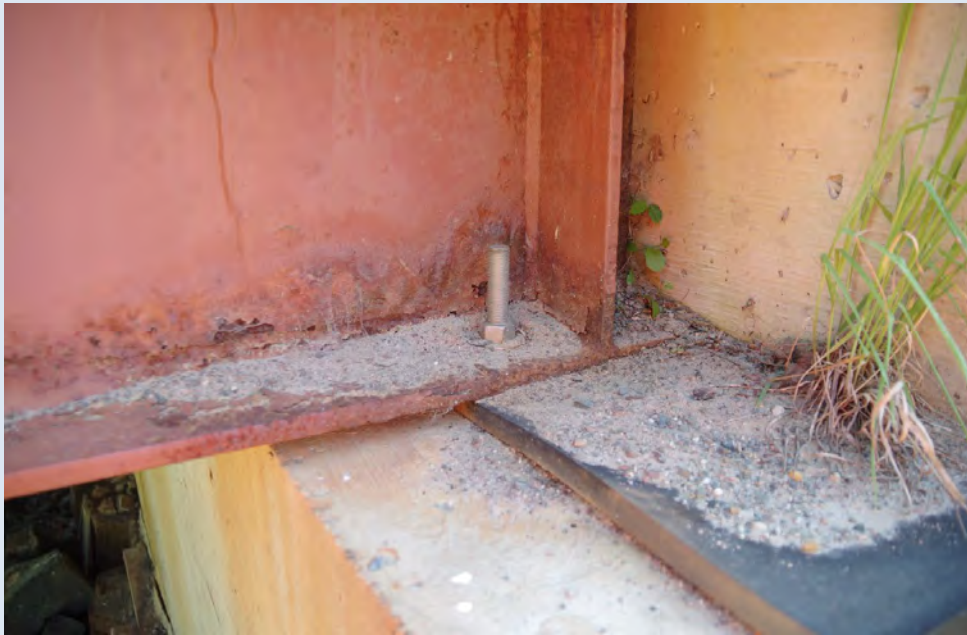
Photo No.: 7

Typical condition of bridge bearing. Note minor corrosion of girder.

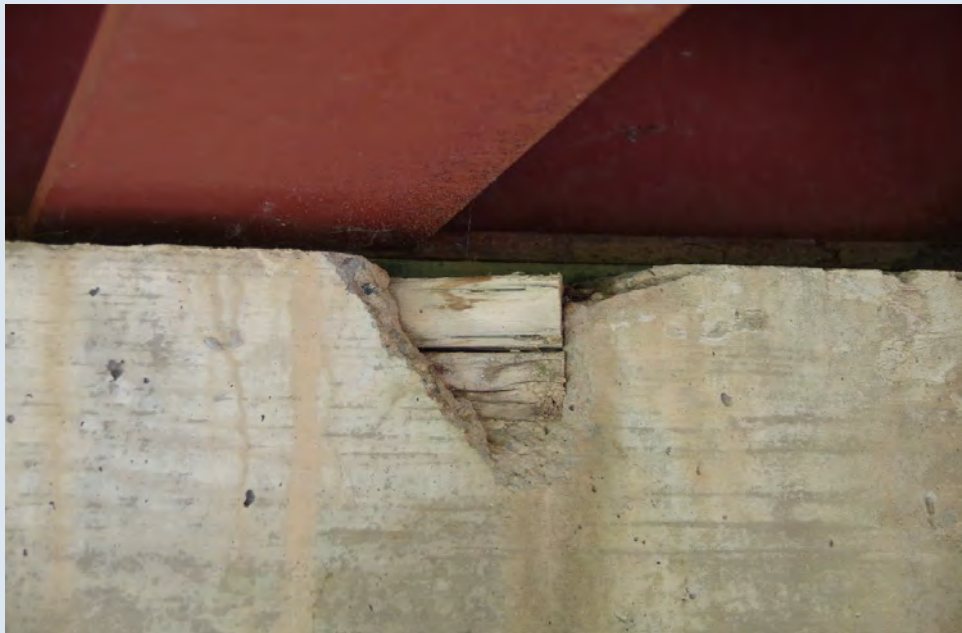
Photo No.: 8

Construction defficiency - wood blocking embedded in concrete.
