Township of Macdonald, Meredith & Aberdeen Additional

Biennial Bridge and Culvert Inspections 2024

October 2024

KEC Project 2436

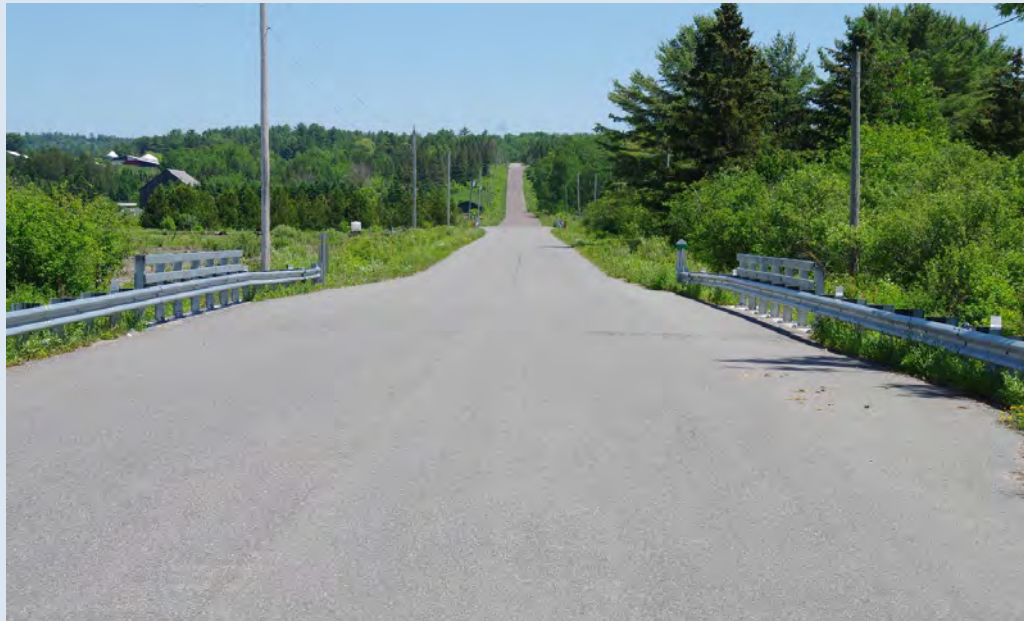
Photo No.: 1

West approach

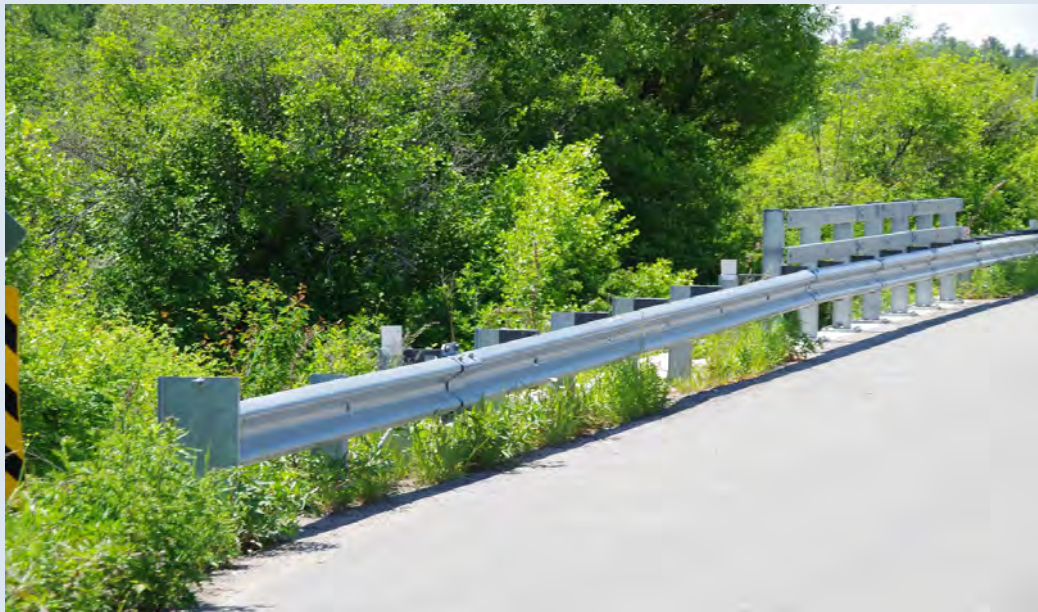
Photo No.: 2

Typical guide rail condition

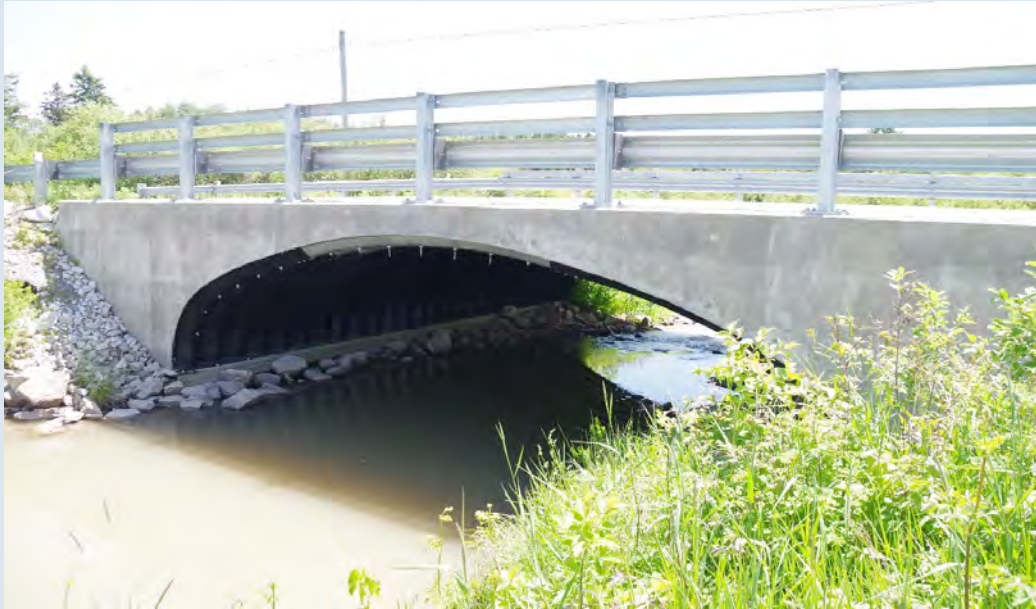
Photo No.: 3

North (upstream) elevation.

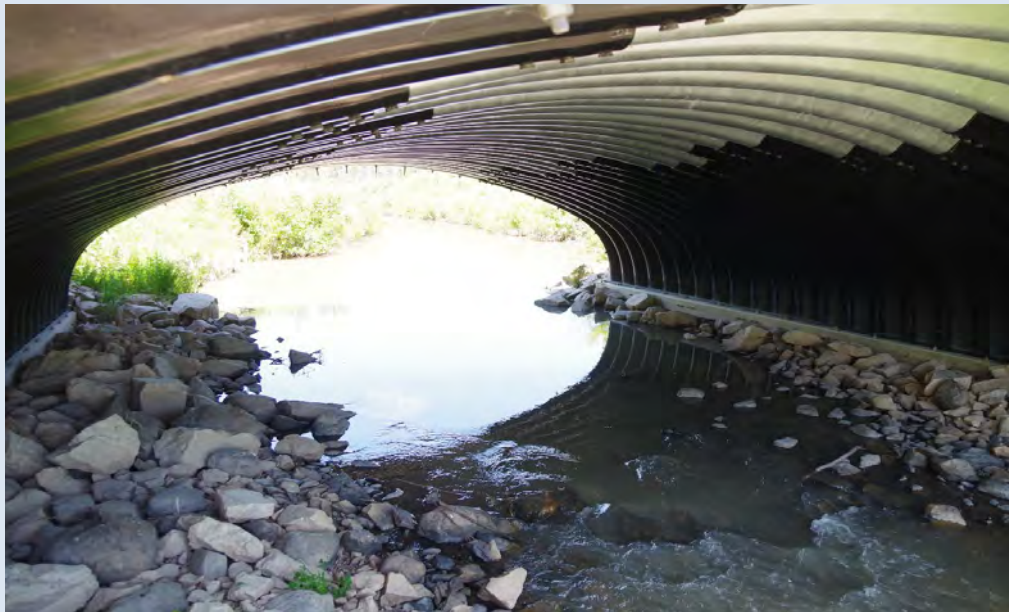
Photo No.: 4

View through culvert, looking north.

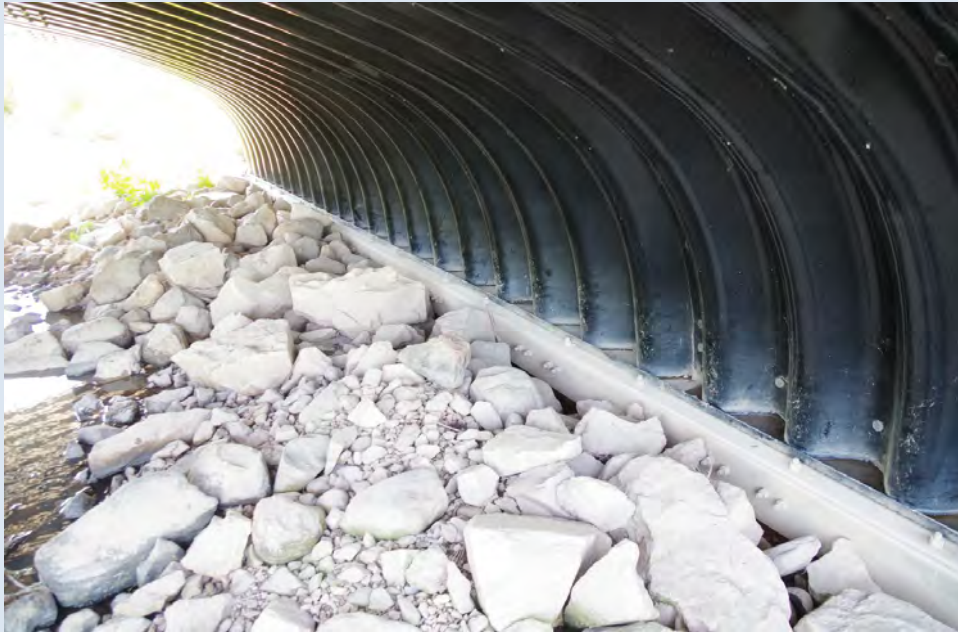
Photo No.: 5

View of foundation connection.

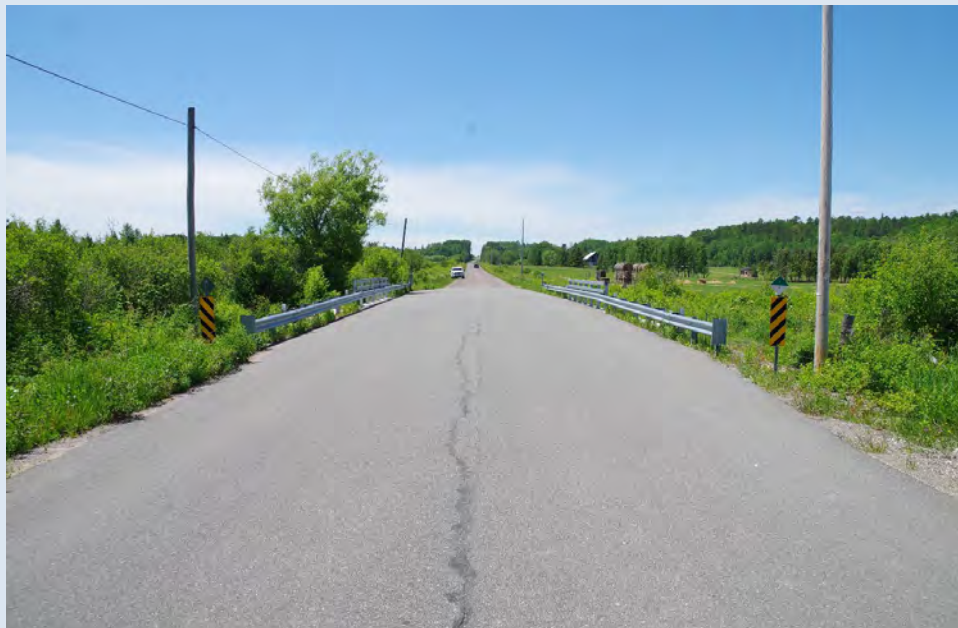
Photo No.: 6

East approach.

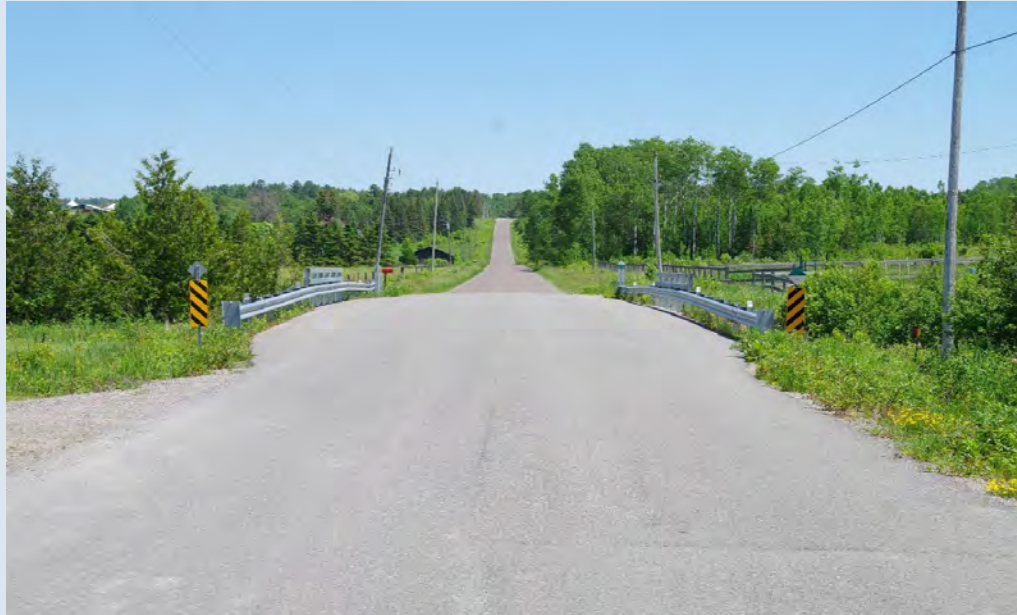
Photo No.: 1

West approach

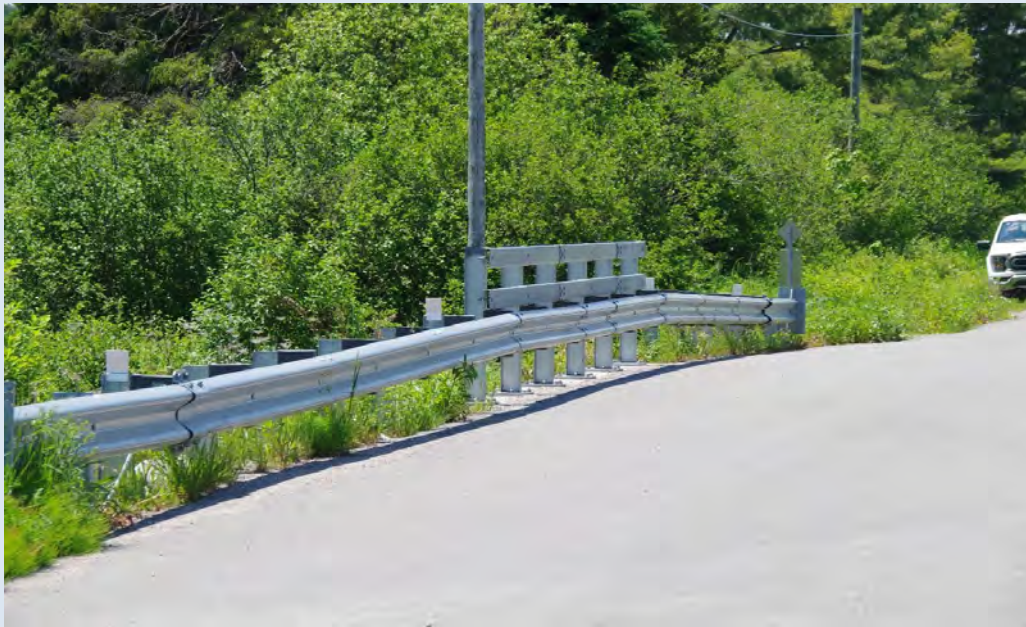
Photo No.: 2

Typical guide rail arrangement.

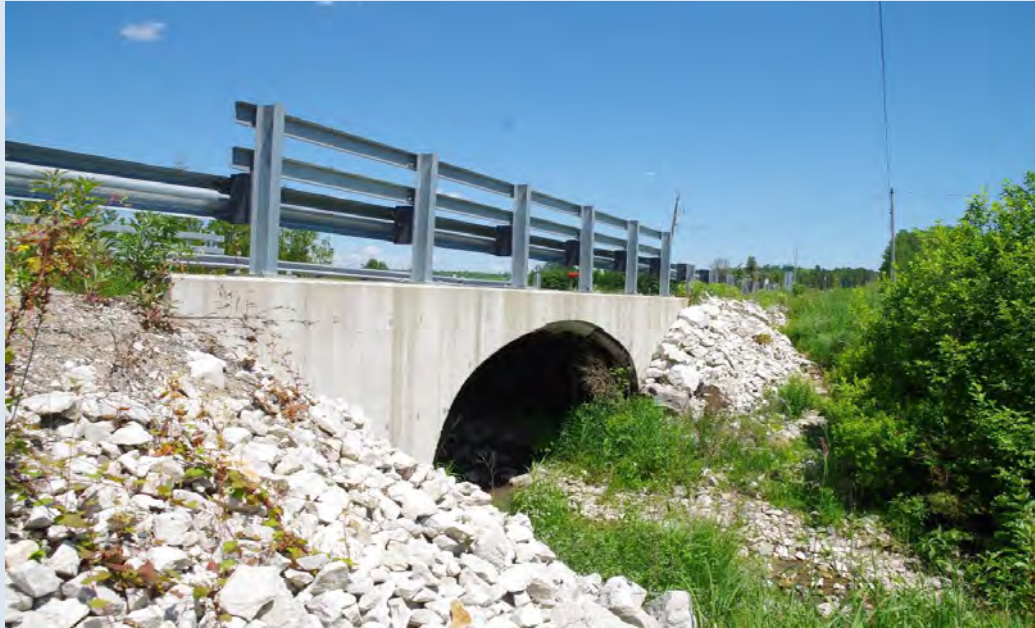
Photo No.: 3

South elevation.

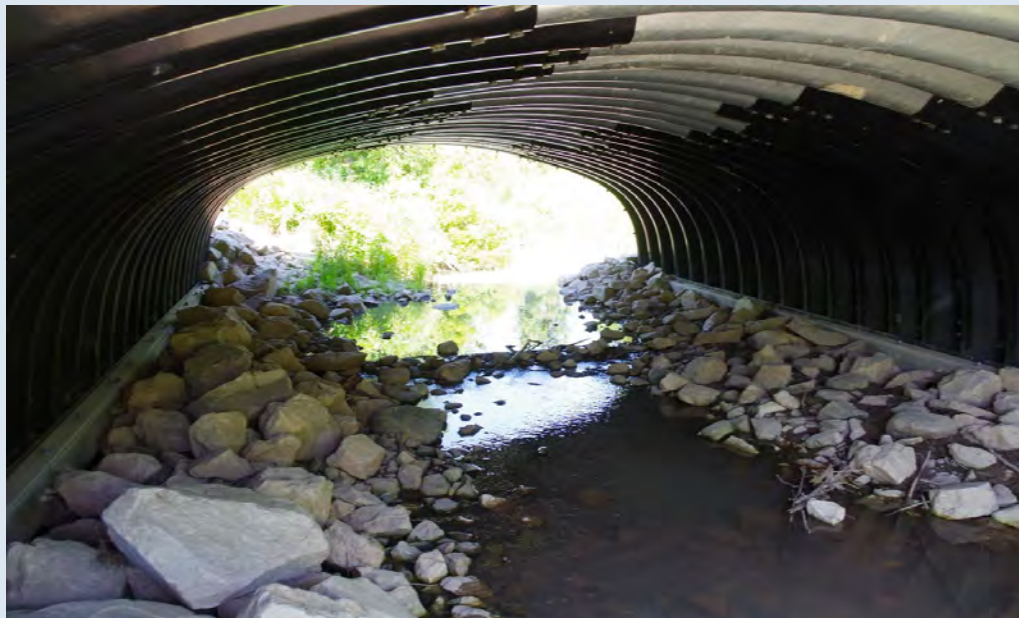
Photo No.: 4

View through barrel.

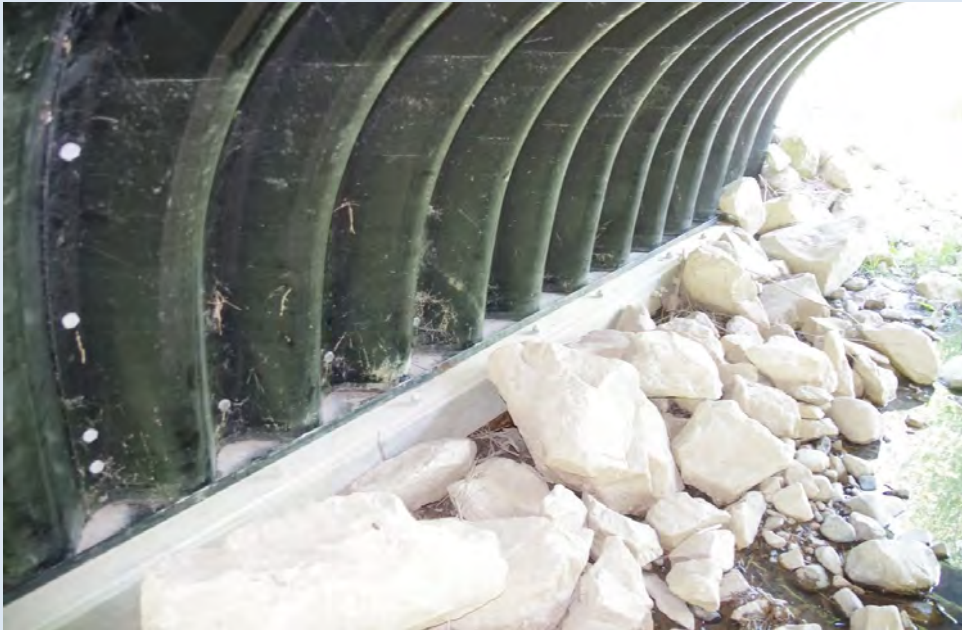
Photo No.: 5

Typical foundation condition

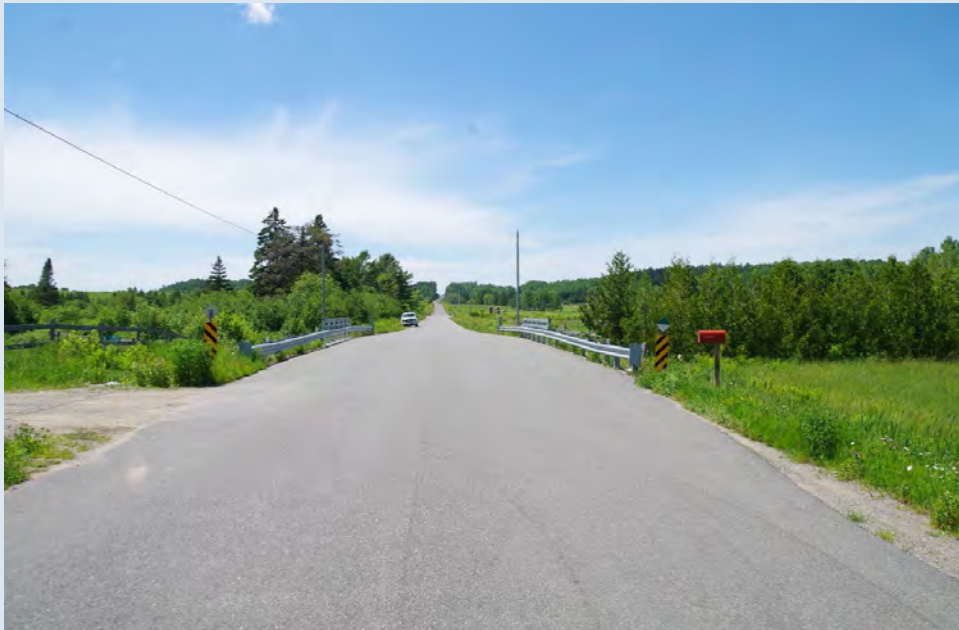
Photo No.: 6

East approach.
