## Memorandum

KEC Ref: 2534.02

**Re: Echo Bay Environmental Centre  
Raw Water Intake Pipe and Intake Structure Inspection**

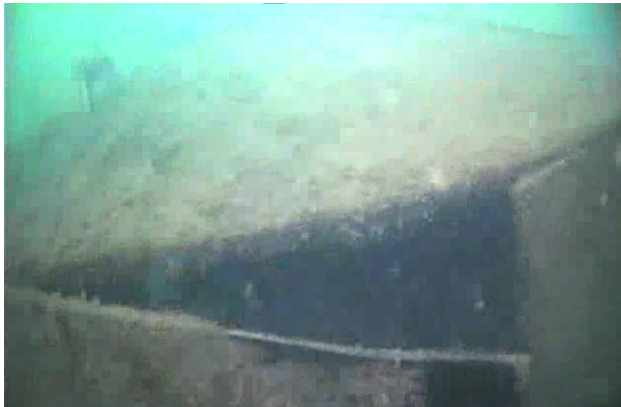
Inspection revealed that one (1) quadrant of the PE conical cover has a loose side panel (Photograph 1) adjacent to a missing cover fastener and the 25mm diameter Schedule 80 PVC diffuser tube is no longer attached to the cover. Available as-built drawings show a total of four (4) 10mm diameter, 75mm long stainless-steel (SS) bolts with SS wire and clevis pin on top of the cover but there are only three (3) bolts visible. Also, the PE drum cover is loose (Photograph 2) as a 10mm diameter, 75mm long SS pin with SS wire and clevis pin is missing. The 50mm diameter chlorine line casing is secured to the side of the 610mm diameter PE riser pipe between the PE conical cover and drum cover. The exterior of the intake structure is coated in a layer of marine growth.

Photograph 1: Loose polyethylene conical cover

It appears that the intake pipe is in good condition with no obvious indications of pipe wall failure or bad/poor fused joints. As noted, one of the concrete pipe ballasts is misaligned and a SS strap supporting the 50mm diameter chlorine line conduit is loose on another. The intake structure appears to be in fair condition with the exceptions being a portion of the PE conical cover has a loose side panel and fasteners on both the conical cover and drum cover are missing.

It is recommended that the missing PE conical cover fastener is replaced and the PE conical cover panel as well as the 25mm diameter diffuser tube are both reattached to the structure. The missing PE drum cover fastener should also be replaced as well as the adjustment of the loose SS strap and realigning of the concrete ballast should be coordinated with the completion of the intake structure repairs. Additional review would occur prior to realigning the ballast to ensure that this can be accomplished without damaging the intake pipe.

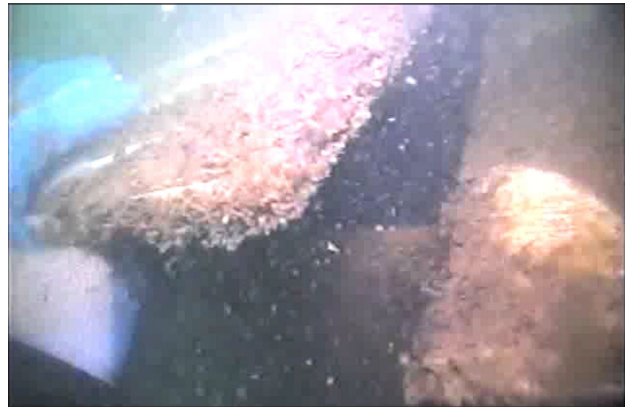
Photograph 2: Loose polyethylene drum cover

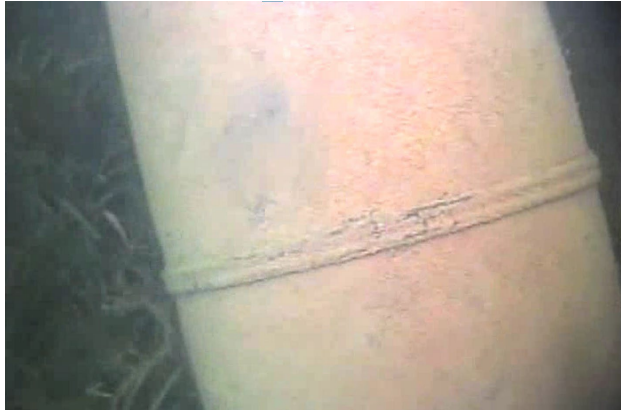
The exterior of the SDR26 PE intake pipe appears to be in good condition and is coated in a thin layer of marine growth and sediments (Photograph 3). Each concrete pipe ballast (Photograph 4) is secured with two (2) 25mm diameter threaded bolts and no missing or loose bolts were noted during the inspection.

Photograph 3: Fused HDPE intake pipe

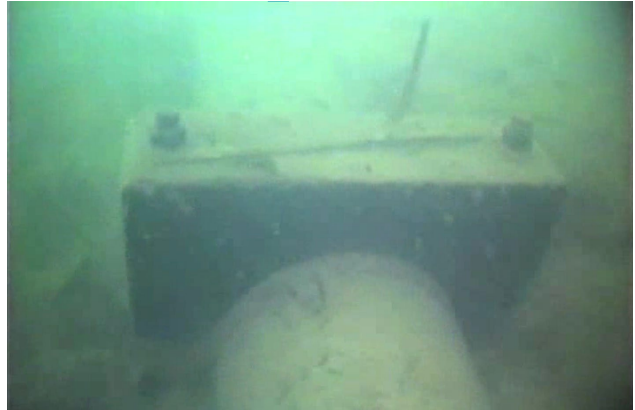
Photograph 4: Concrete ballast

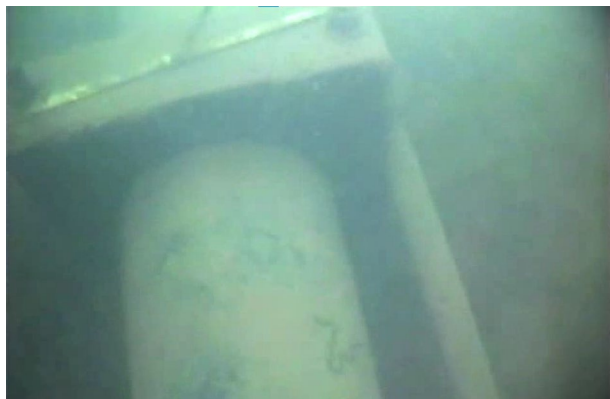
A SS strap is wrapped around each concrete ballast and secures the 50mm diameter chlorine line conduit to the south side of the ballasts (Photograph 5), which differs from available as-built drawings that show the conduit on top of the intake pipe.

Photograph 5: Chlorine line conduit strapped to ballast

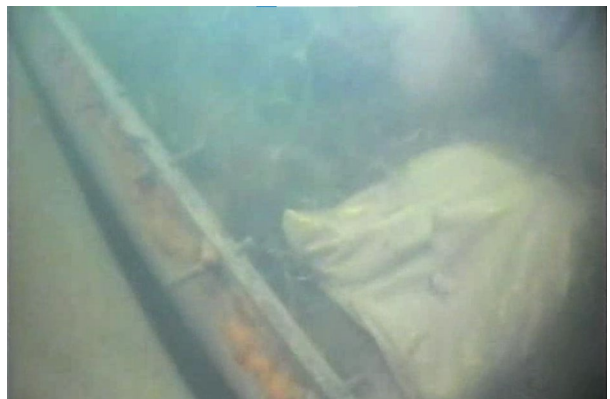
Approximately 430m from the intake structure location, there appears to be a repaired section of chlorine line conduit (Photograph 6) comprising what appears to be a cloth wrap and bolted steel flat bar installed along the side of the conduit as well as sandbags nearby.

Photograph 6: Chlorine line conduit repair

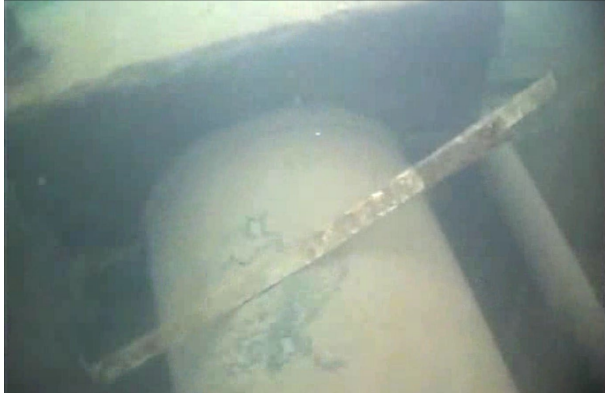
Approximately 20m inshore from the apparent chlorine line casing repair location, there is a loose SS strap (Photograph 7) that the diver was unable to install back on the concrete ballast. The SS straps on the remaining concrete ballasts are secure providing some support for the conduit.

Photograph 7: Loose stainless steel casing strap

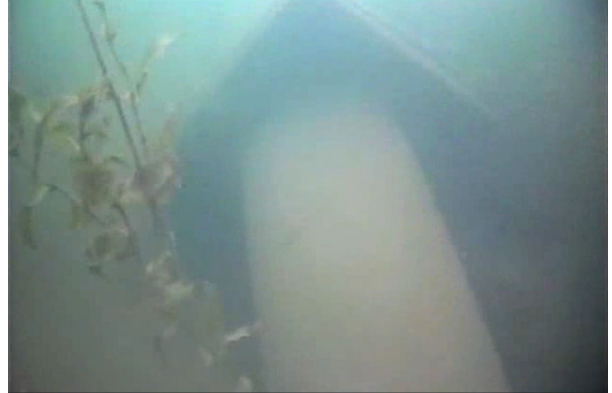
Approximately 93m inshore of the loose SS strap there is a concrete ballast is misaligned (Photograph 8) and appears to be resting on top of the 50mm diameter chlorine line casing, pushing it into the lake bottom.

Photograph 8: Crooked concrete pipe ballast
