**Re: Echo Bay Sportsplex  
Building Review**

At the request of the Township, Kresin Engineering Corporation (KEC) attended the Echo Bay Sportsplex building on September 16<sup>th</sup>, 2025 to carry out a visual review of the building, including accessible structural components. The purpose of this assignment is to address recommendations made in a previous building condition assessment (BCA), including the completion of a structural review and repainting.

This review is focussed on the pre-engineered metal building (PEMB) portion of the Sportsplex, which encloses the ice pad area.

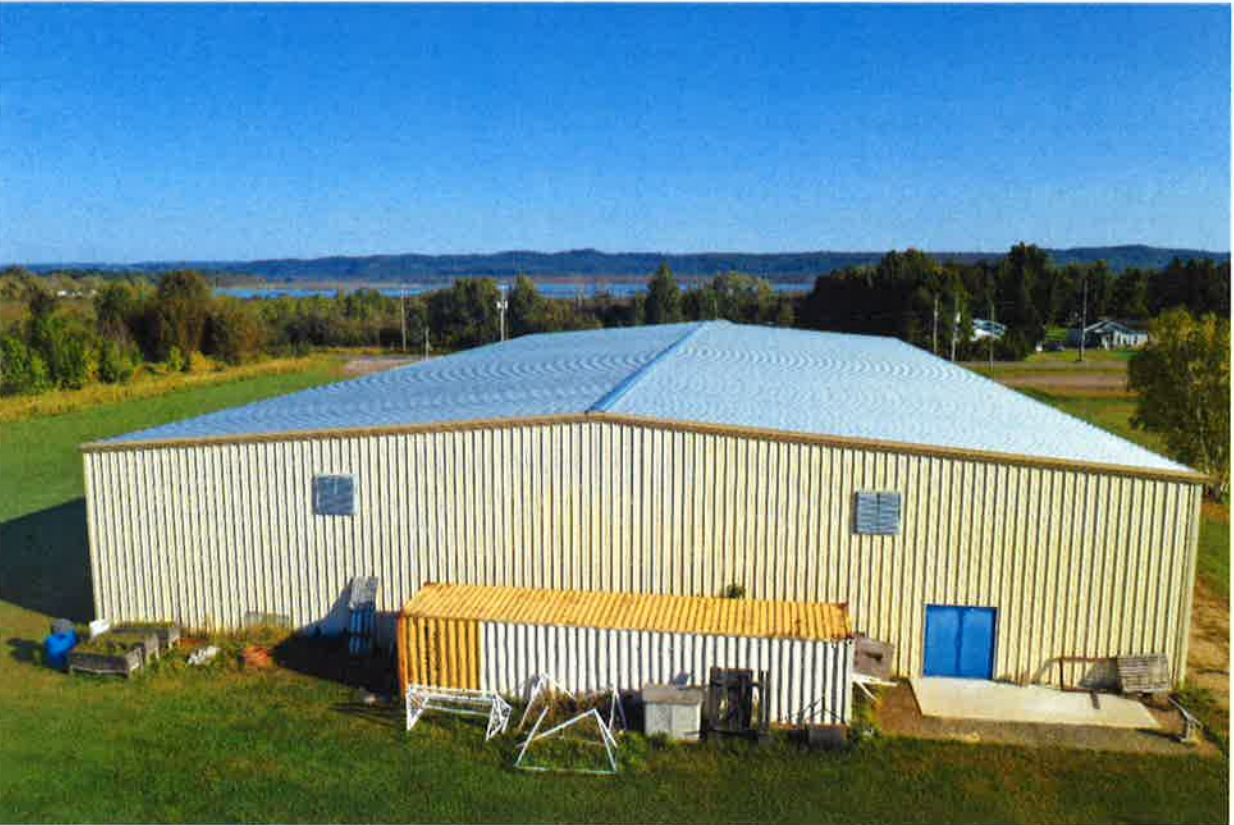
8. Exhaust fans and make-up air louvres are installed on the east and west sides of the building. There are four abandoned ventilation fans/louvres.
9. A small jib crane has been installed on building frame 7.

Photo 2: View of south end of arena building. Note 2 ventilation fans no longer in-use.

1. The outlets for the roof downspouts at the west side of the building should be directed away from the foundations.
2. The abandoned ventilation system components should be removed and the associated building penetrations should be properly closed in.
3. Stored equipment and material should be moved away from the building to allow access for weed trimming and vegetation management.
4. The jib crane installed at building frame 7 is posted as “out of order”. This device should be physically removed. If a jib crane is needed for operational purposes, a certified lifting device should be installed.

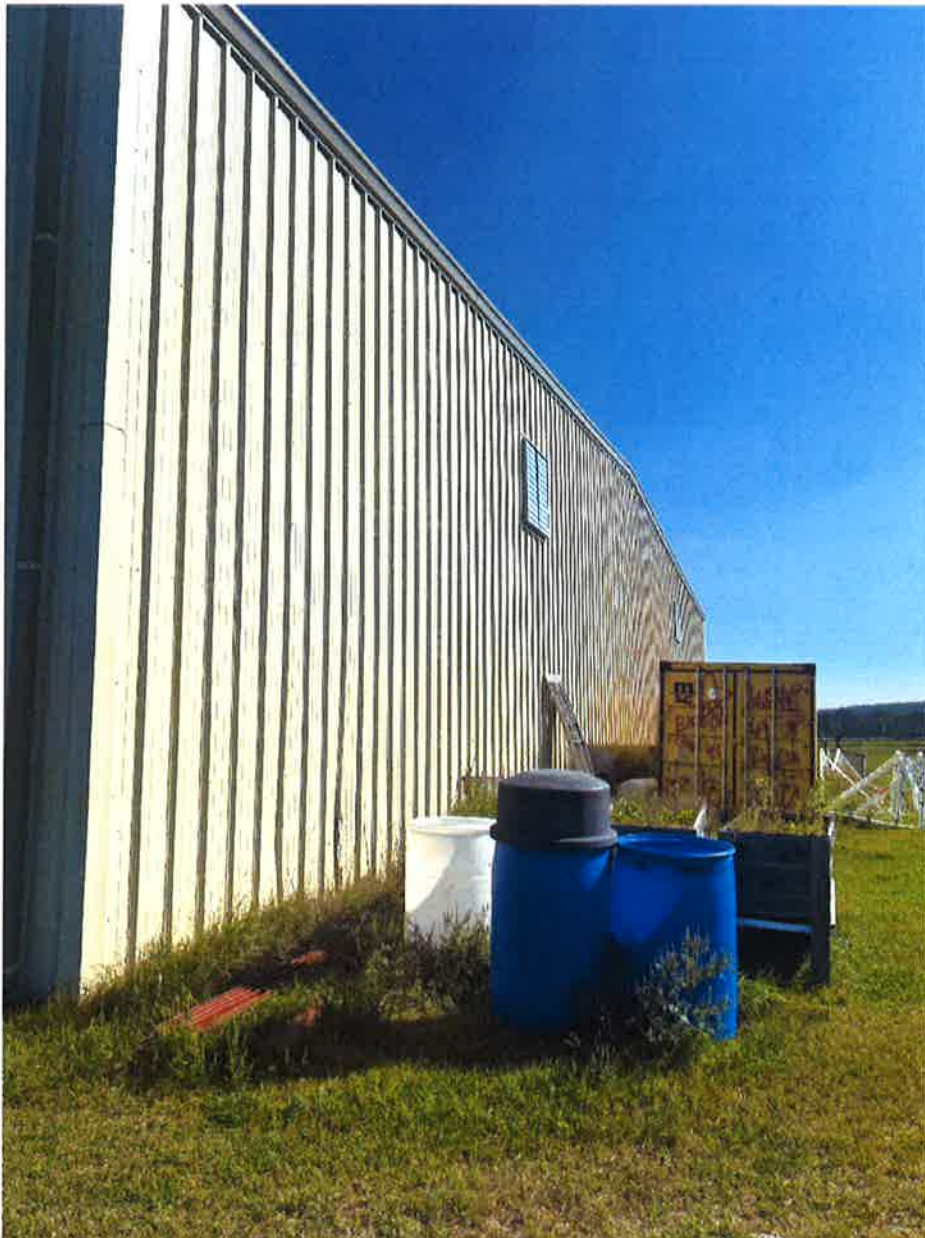
1. The exterior of the Sportsplex generally appears well kept and in excellent condition.
2. Some materials and equipment are stored near and against the exterior of the building. (Photos 3 and 4)
3. The roof over the PEMB is equipped with gutters and downspouts. On the east side of the building, downspouts are directed to in-ground drainage pipes; however, on the west side, the downspouts discharge directly adjacent to the building foundations. (Photo 5)

Photo 3: Storage adjacent to building

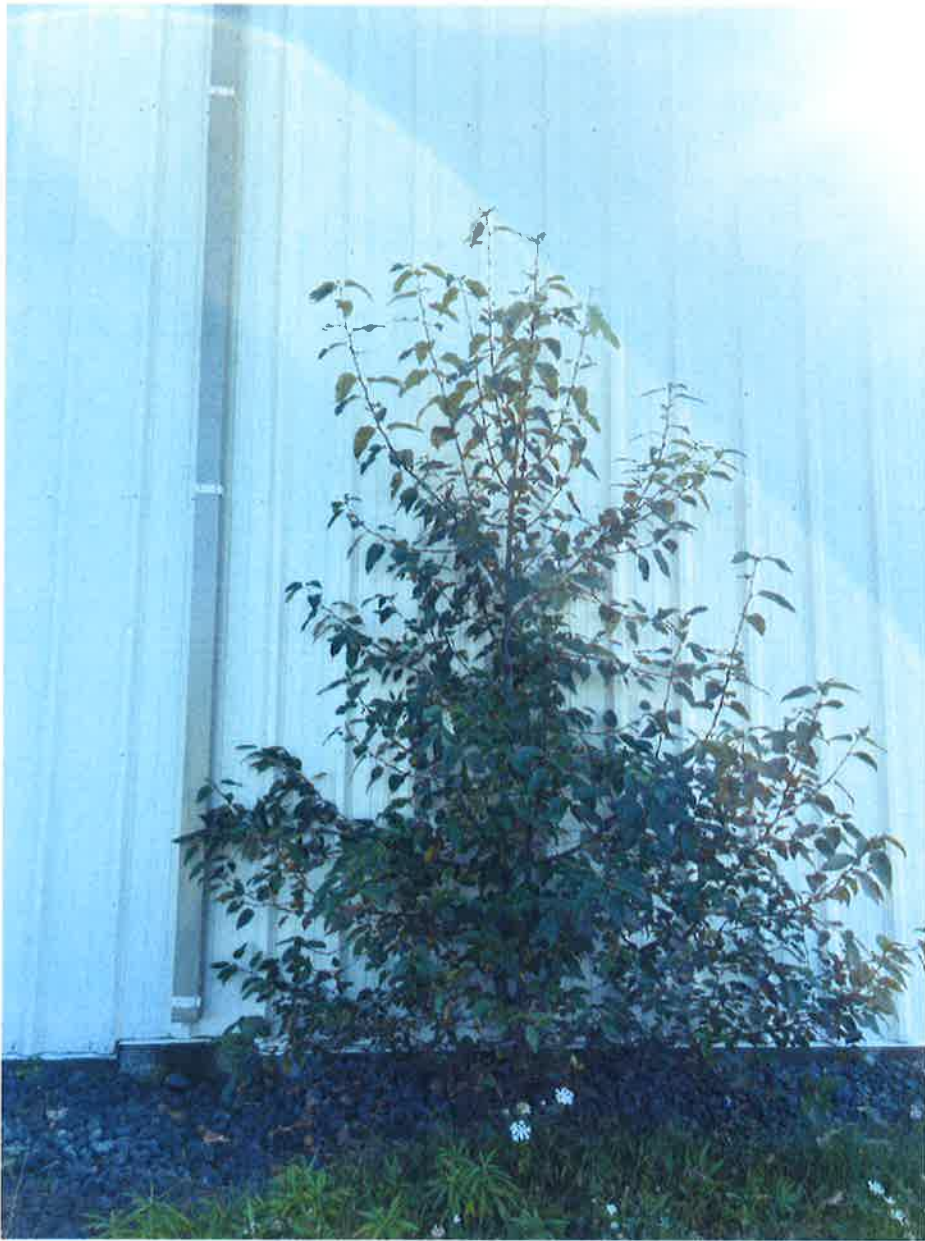
Photo 4: Vegetation growth at building foundation.

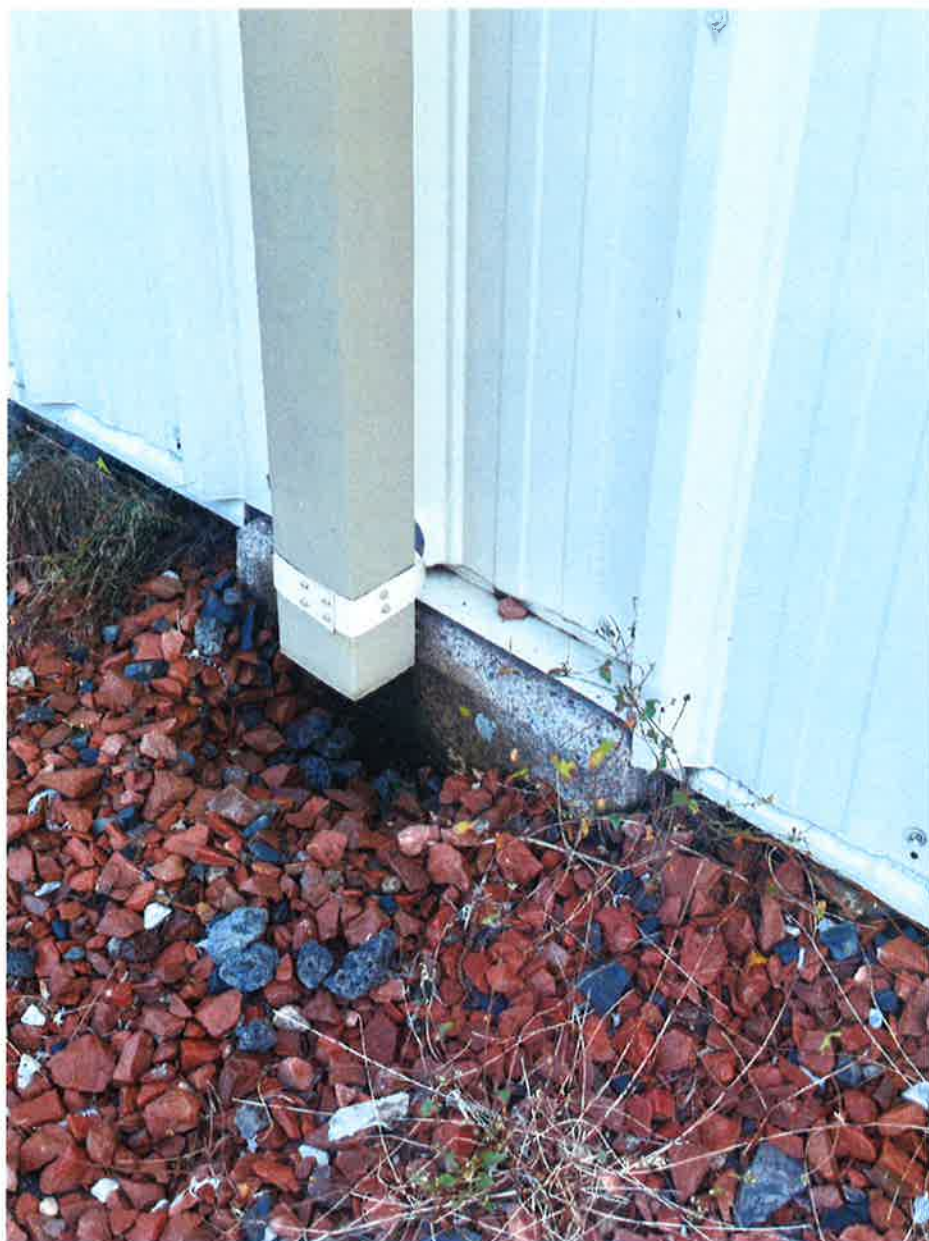
Photo 5: Roof drain discharge directed to building foundation.

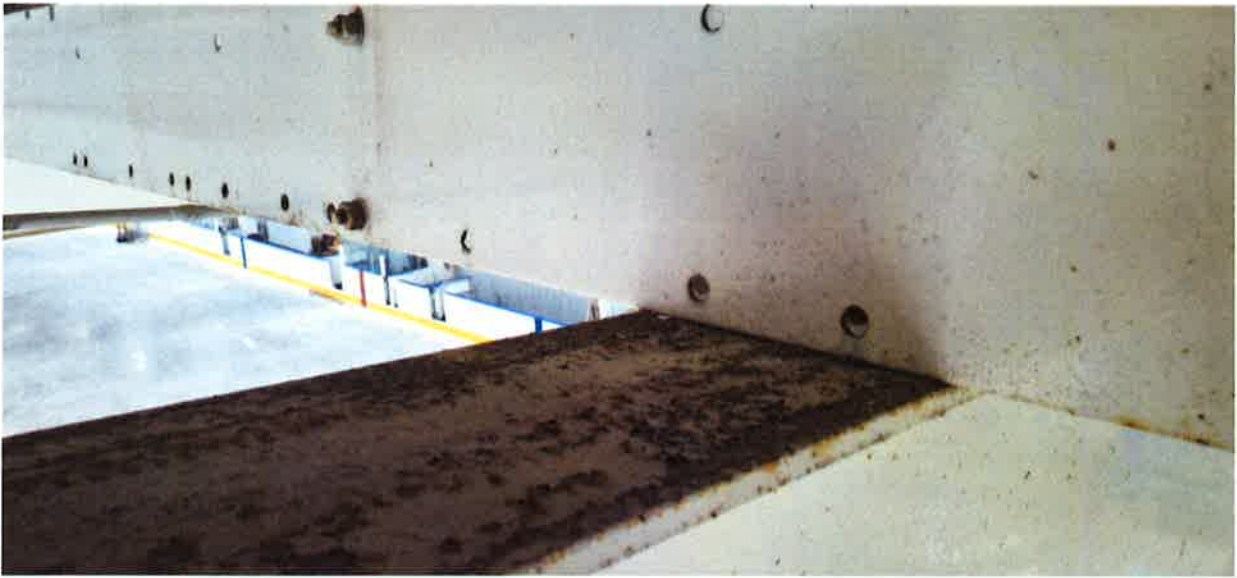
4. Minor surface rust is present on the PEMB structural steel such as building frames and columns. The most corroded areas appear to be the tops of the building frames. (Photos 6 and 7)

The previously completed BCA recommended repainting the structural steel due to the presence of minor rust. The paint system on structural steel provides an important protective barrier to prevent/manage corrosion due to environmental moisture. In an ice rink arena, moisture is routinely introduced during icemaking and operational activities, which typically results in

condensation on the steel structure contributing to corrosion. Occasional repainting is recommended as a preventative measure to prolong the life of the structure.

Photo 7: Minor surface rust on top of building frames. Typical condition.

The Sportsplex PEMB is exhibiting signs of minor corrosion. It is recommended that the Municipality plan for repainting the structural steel in the next 2-5 years. A preliminary budget recommendation for the work is \$200,000.

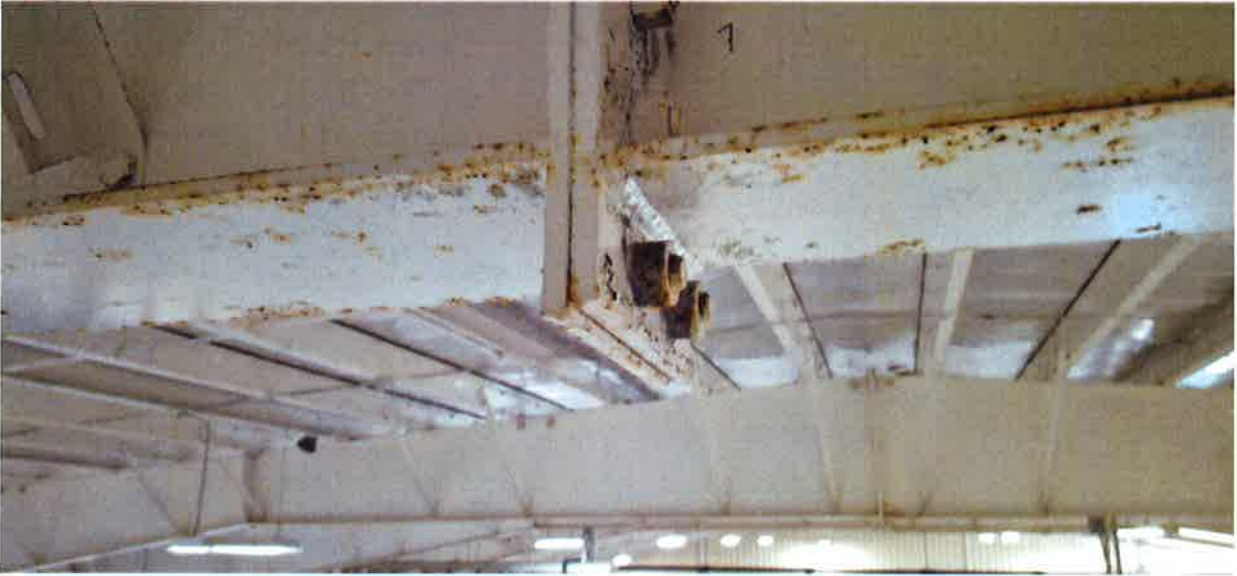
Photo 7: Minor surface rust on bottom flange of building frames. Typical condition.

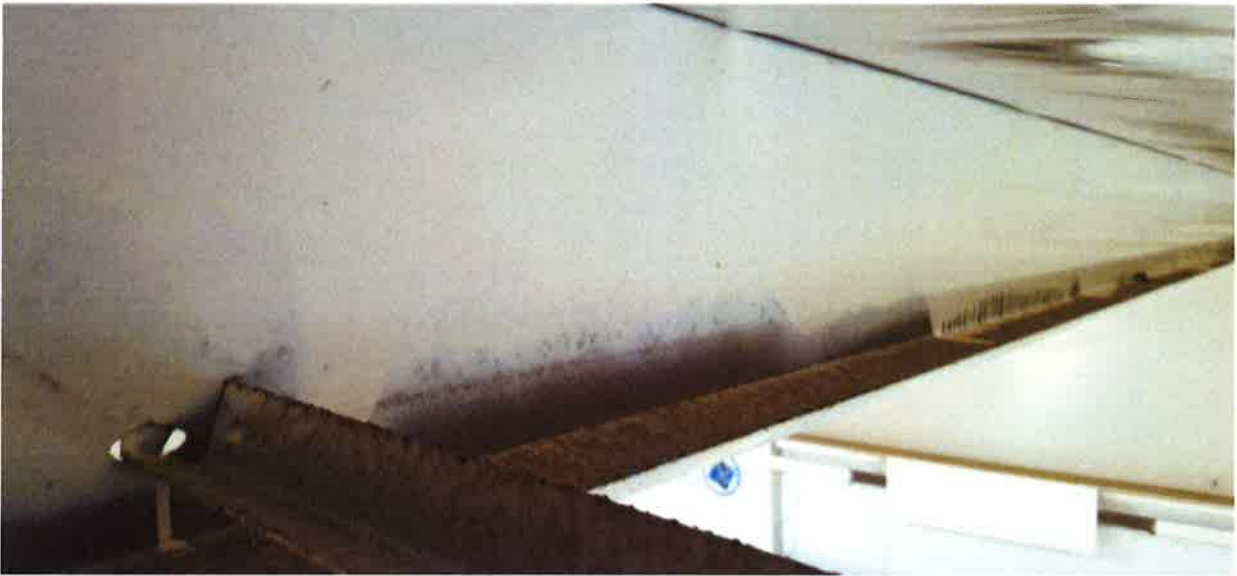
6. The paint coating on the steel is inconsistent in some areas. (Photo 8)
7. Beams have been added between building frames 4 and 5 to support air conditioner mechanical systems. (Photo 9)

Photo 8: Inconsistent paint coating (exposed primer).

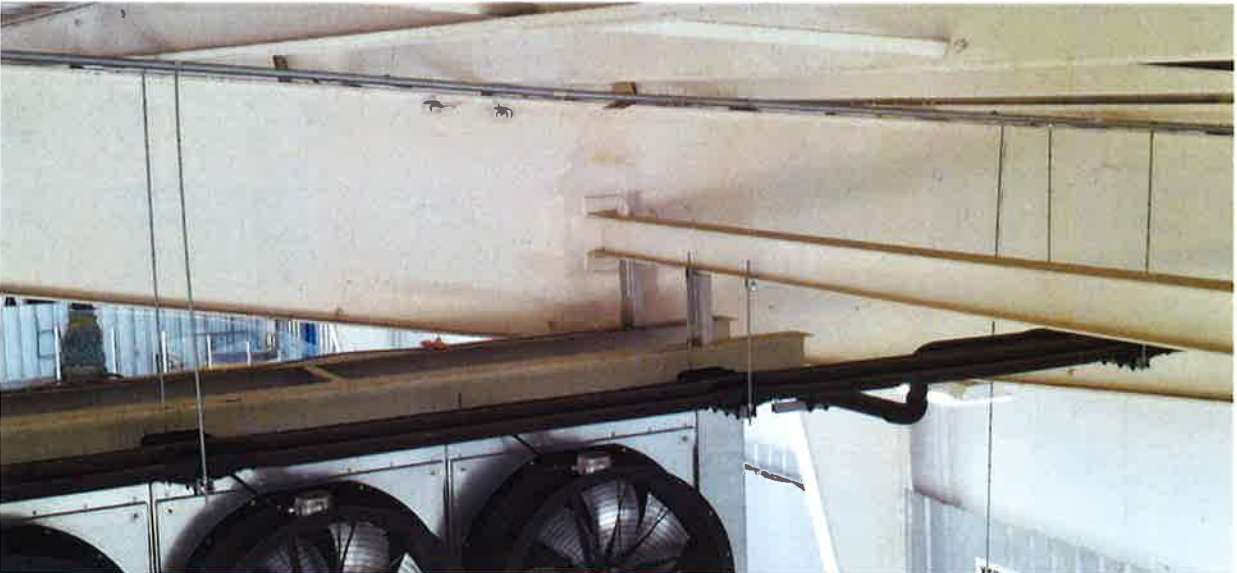
Photo 9: Steel structure installed for air conditioner support.

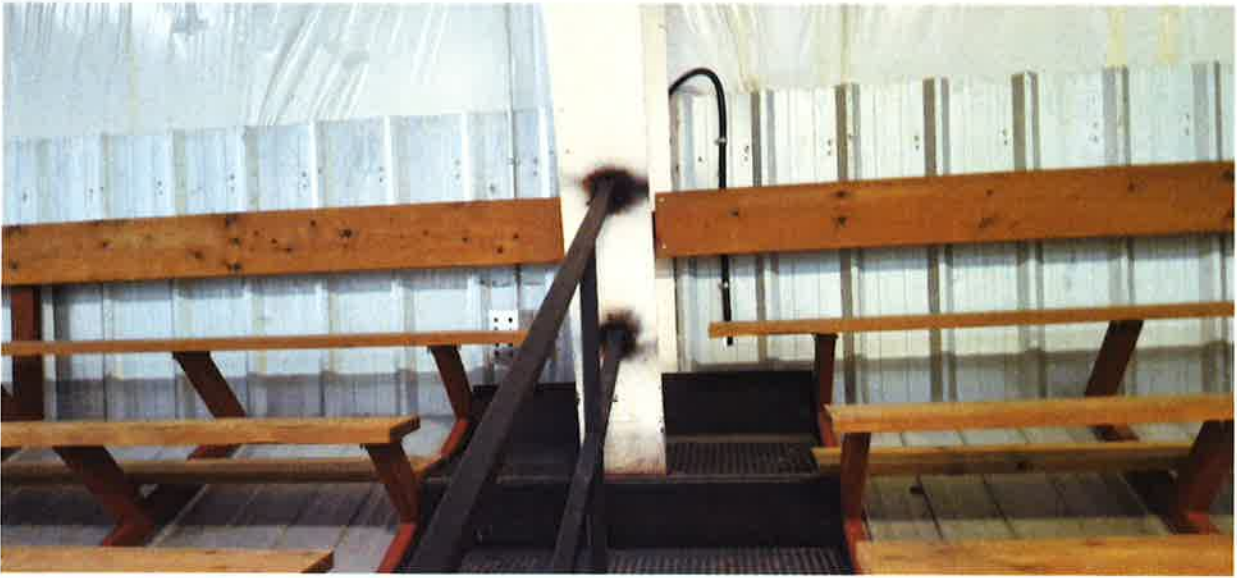
10. Handrails for the spectator seating area have been welded to the building frames. (Photo 10)
11. Overall, the PEMB structure appears in Good to Excellent condition, with no indications of deformation or deflection.

Photo 10: Handrails welded to building frame.

It is also noted that welding attachments such as handrails to the building structural steel should be avoided in the future; if necessary, bolted or clamped connections are generally preferred.
